GILROY UNIFIED SCHOOL DISTRICT

FACILITIES MASTER PLAN

MARCH 2016

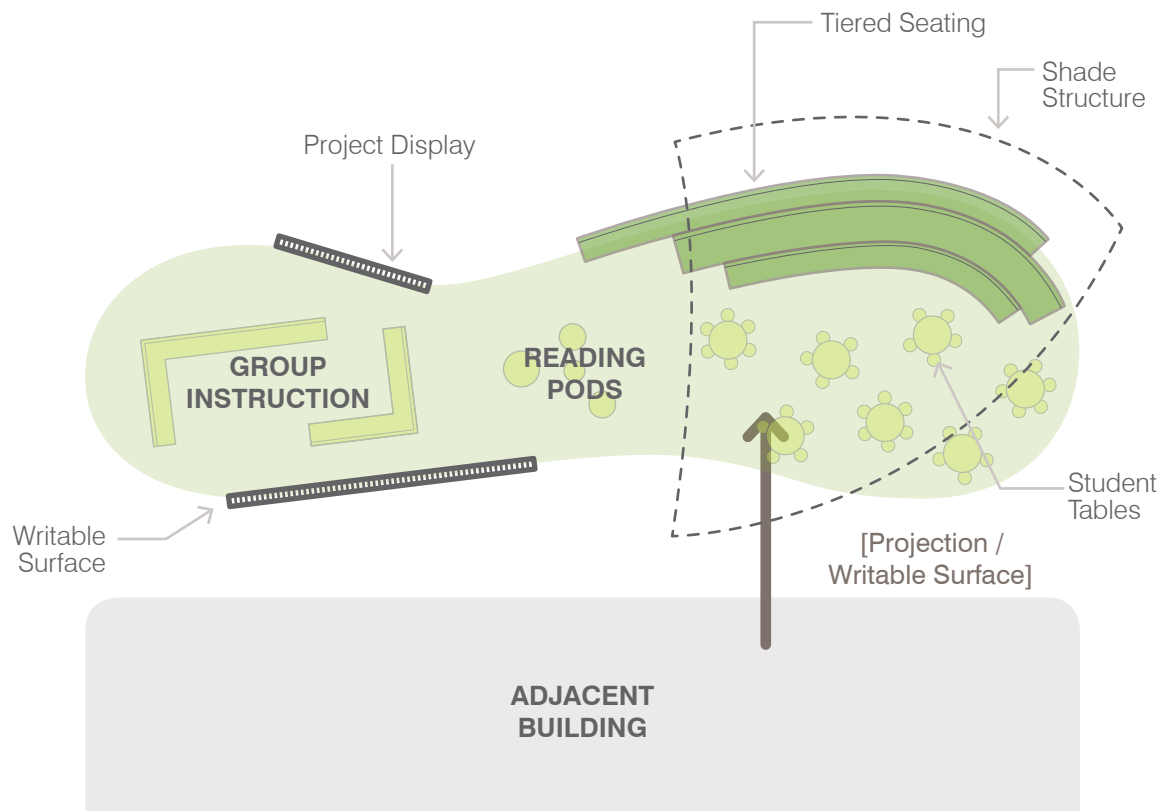
The diagram here provides an idea of what an Outdoor Learning Courtyard could look be. Implementation will depend on site conditions.

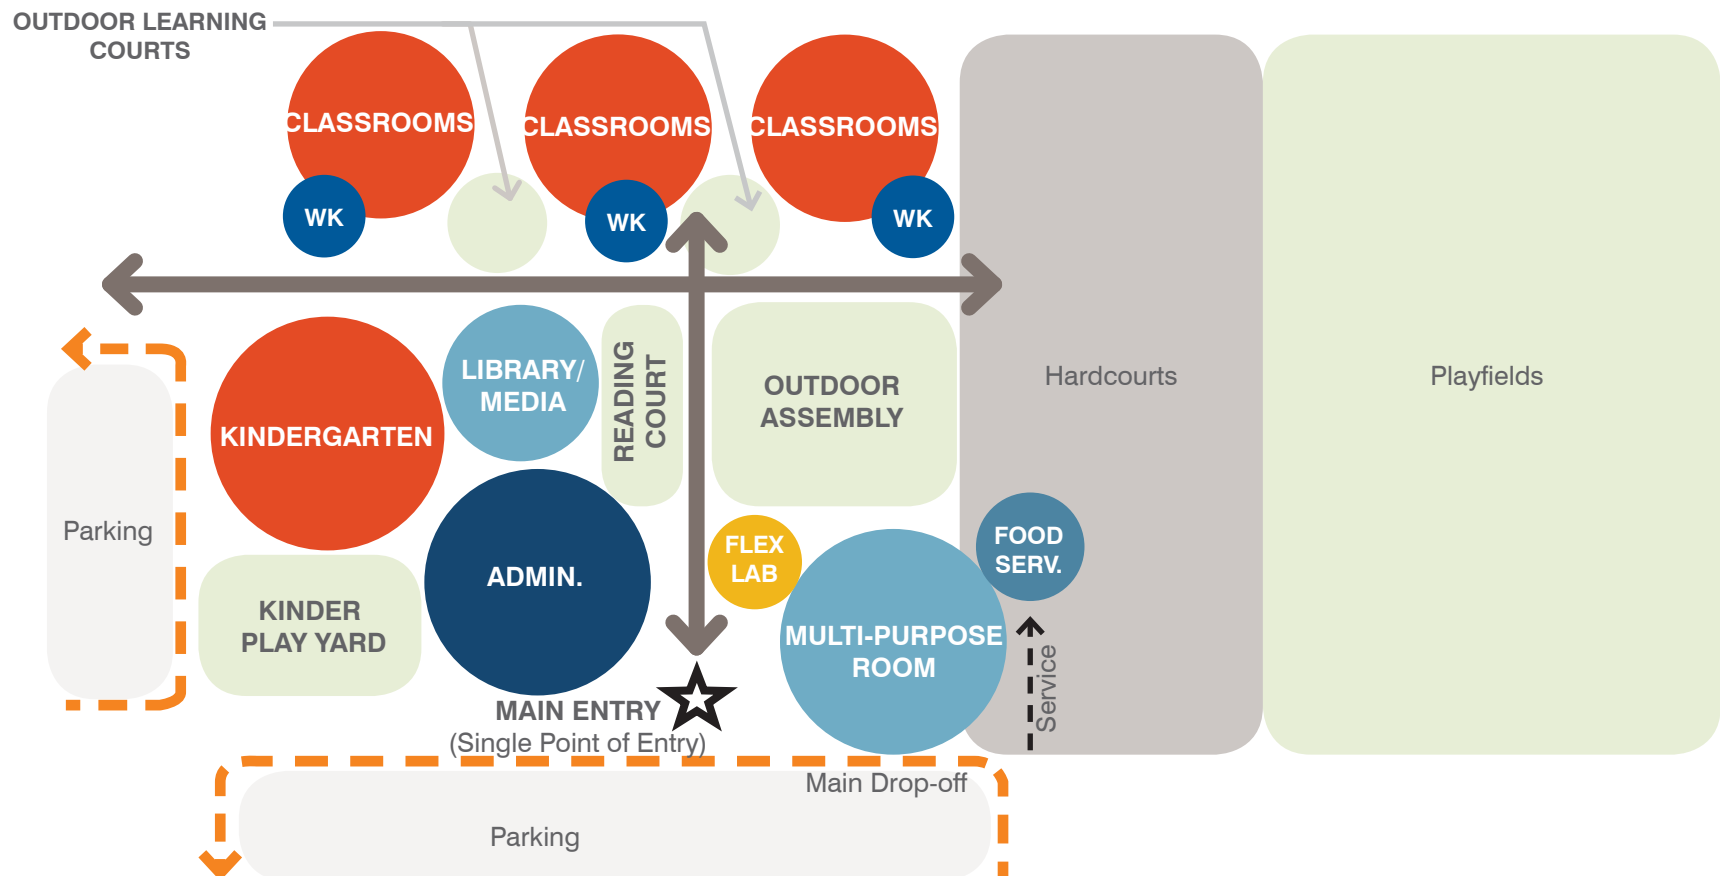
The following is a diagrammatic overall campus. It does not reflect any campus in particular but provides a layout that demonstrates the design considerations as stated within these pages.

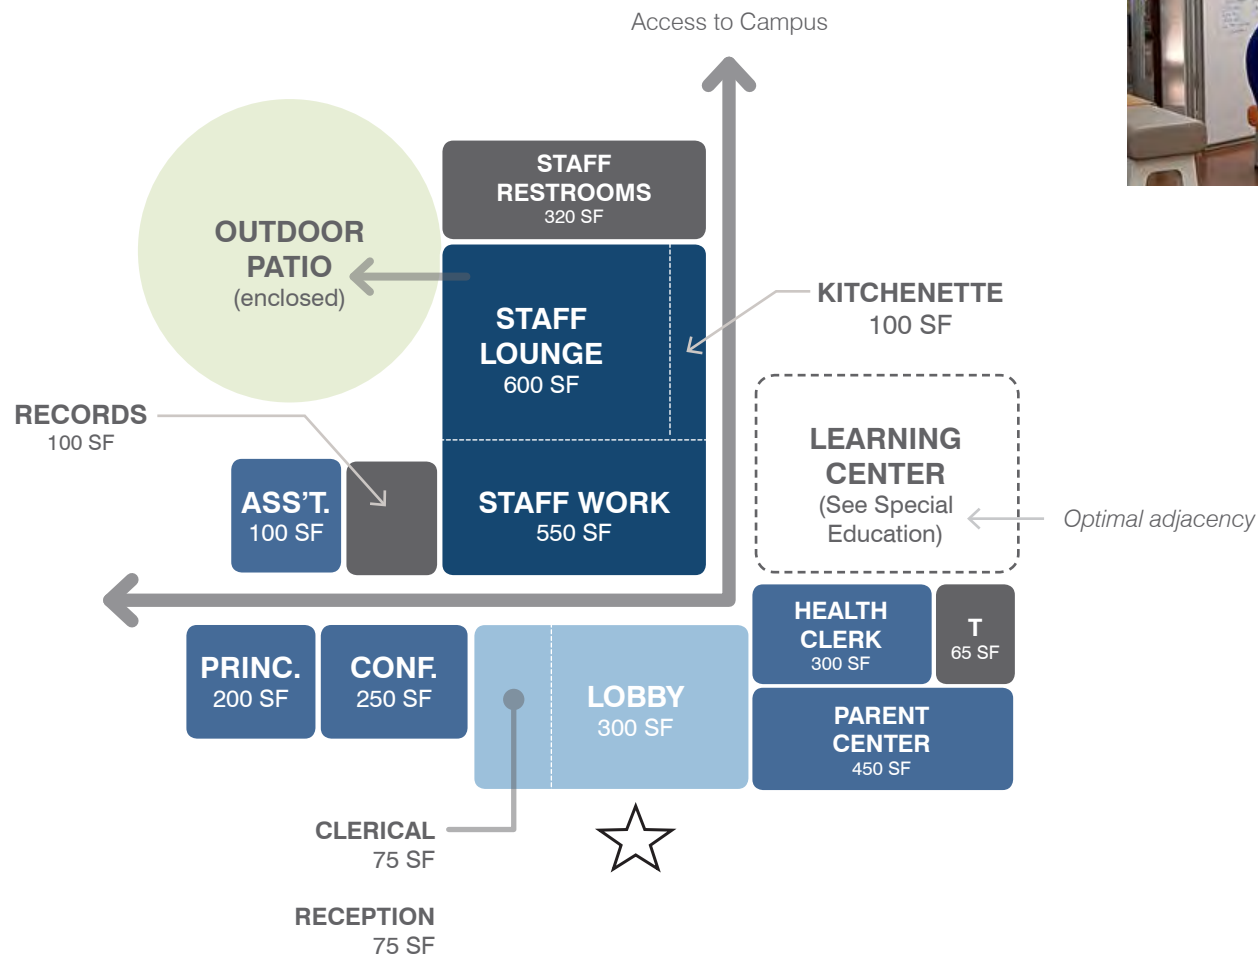
SPACE DIAGRAM

Administration building should be the main public entry of the school. Organize more 'public' functions (Parent Center, Health, and Conference Room) near the Reception/ Lobby area. Locate more 'private' functions (Offices and Staff Work) towards the interior.

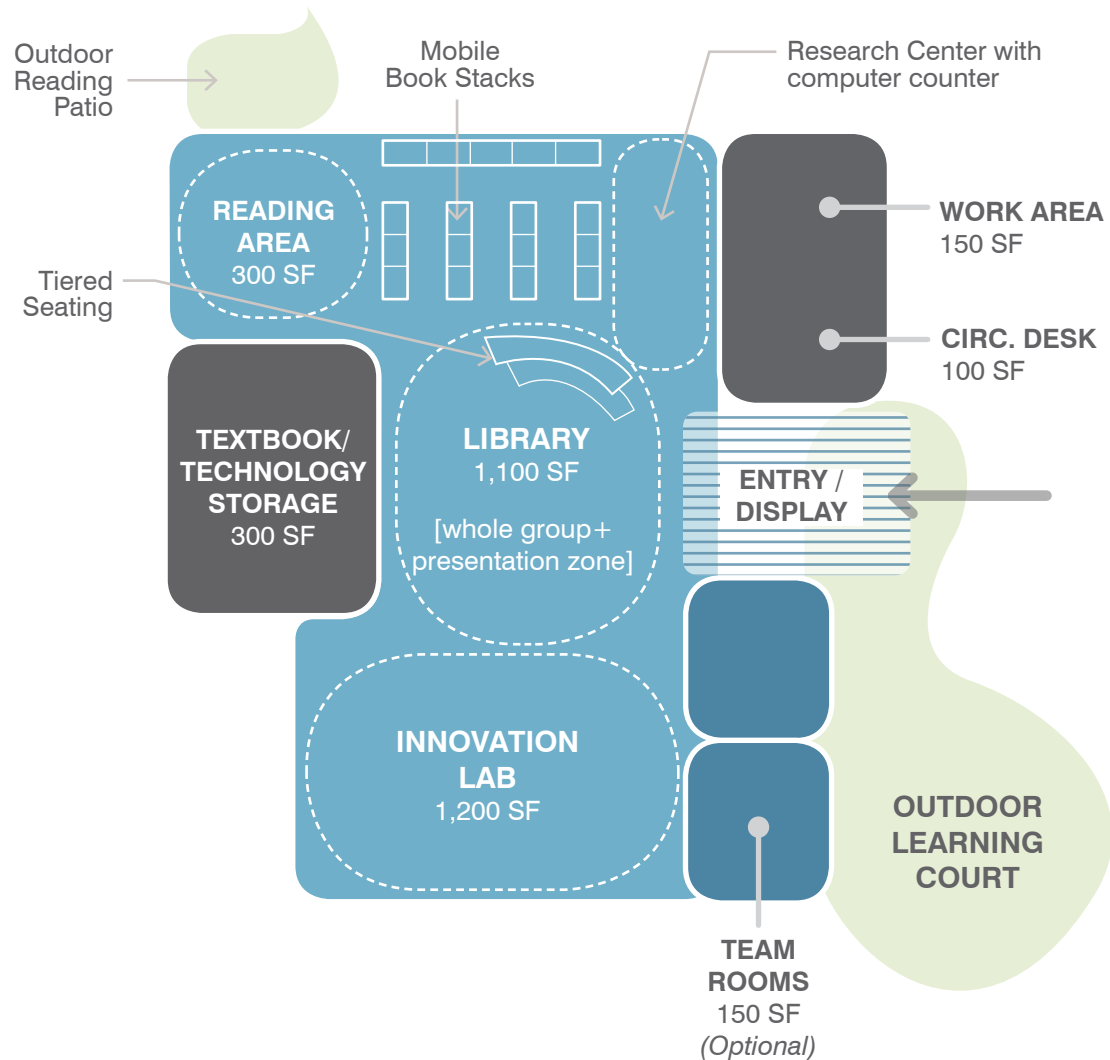
SPACE DIAGRAM

Organize the space to support multiple types of activities and sizes of groups. Design for ease of supervision.

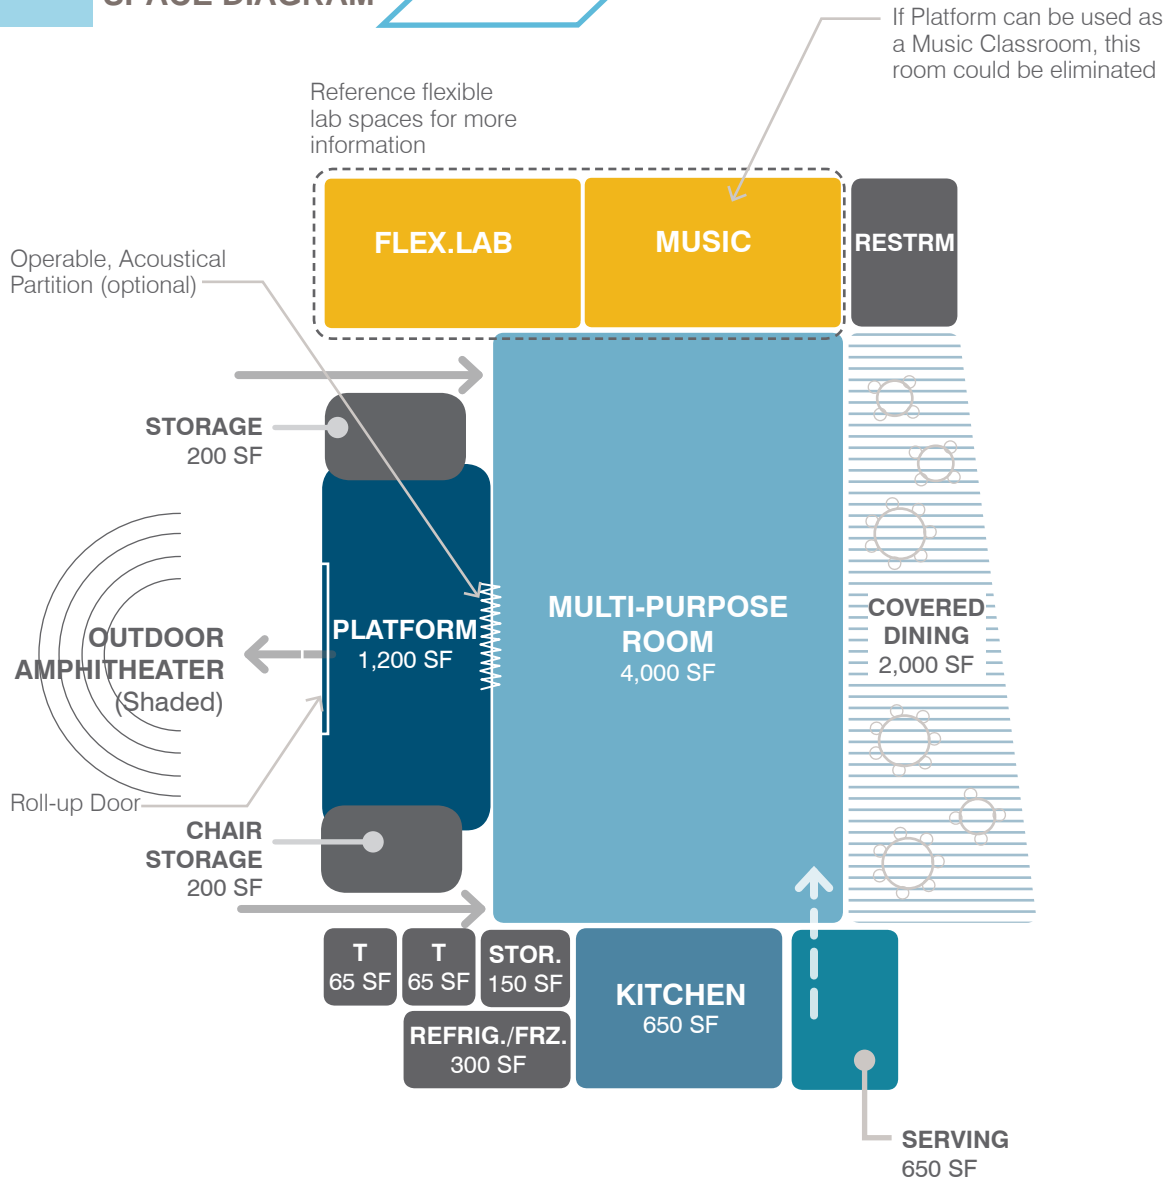
SPACE DIAGRAM

As the main campus Activity Center, the Multi-Purpose/ Food Service building shall be centrally located yet near parking for community events. Service access shall be provided to the kitchen for deliveries.

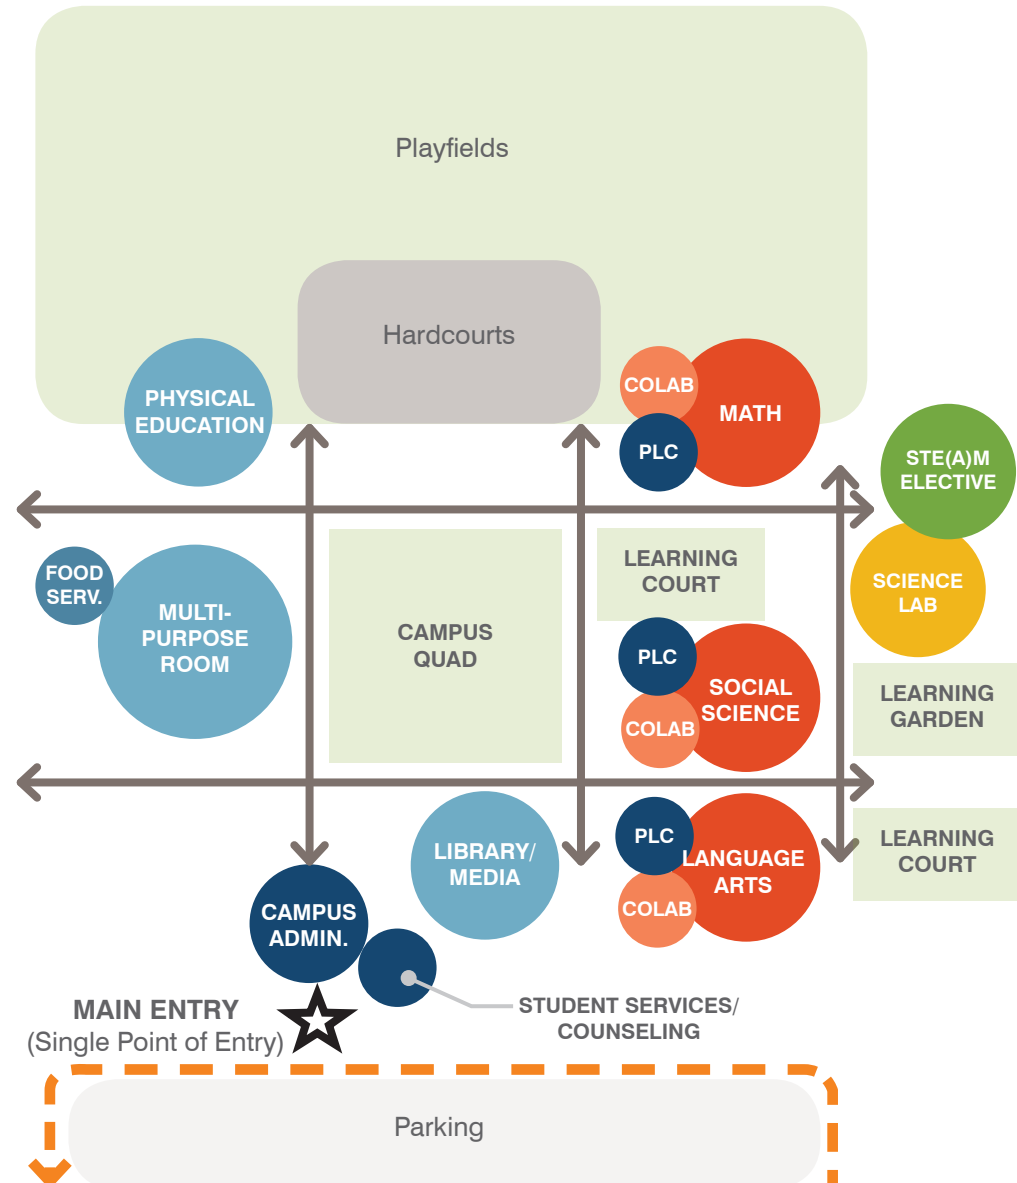
The organization of buildings and site elements should take into consideration supervision and circulation. Provide adequate lighting at parking and exterior circulation areas to allow for safe, after hours staff and District maintenance access. Clear signage should be provided at main entry and throughout the campus.

The following is a diagrammatic overall campus. It does not reflect any campus in particular but provides a layout that demonstrates the design considerations as stated within these pages.

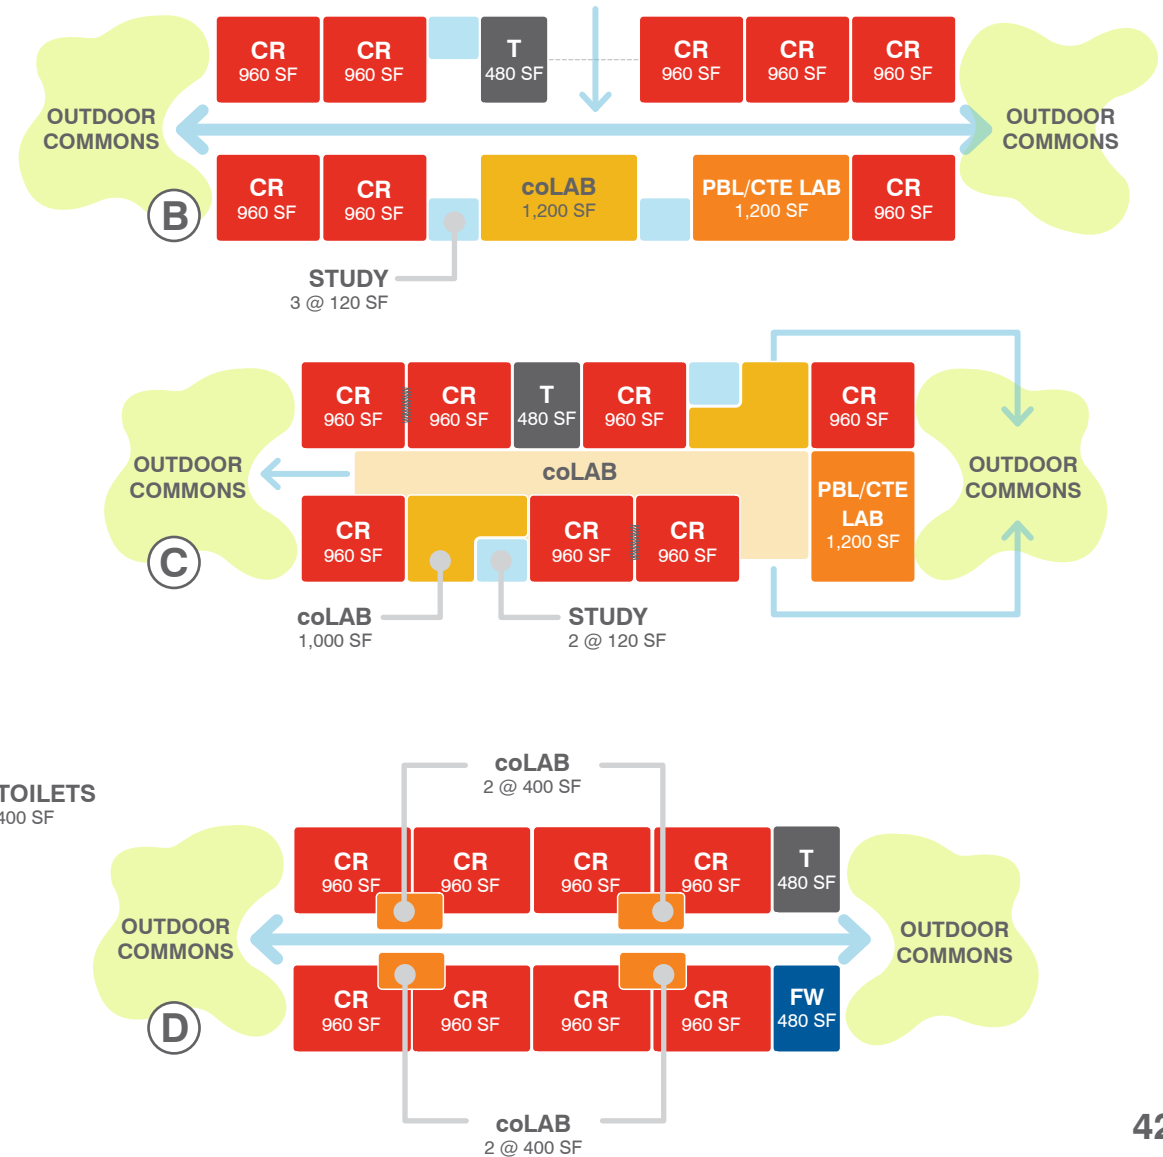
The diagrams on this page demonstrate various learning house configurations that can be applied to new construction and / or major modernization projects as appropriate. The goal is for classrooms to have access to a shared collaboration (co-lab) area where various break out and small group activities could occur. The idea is also to utilize space efficiently so that every space can be a learning space. Co-lab spaces should be very transparent to allow for ease of supervision from the classroom space. Also consider project based learning or career tech labs to be co-located within the learning house to better integrate into the curriculum with core subjects.

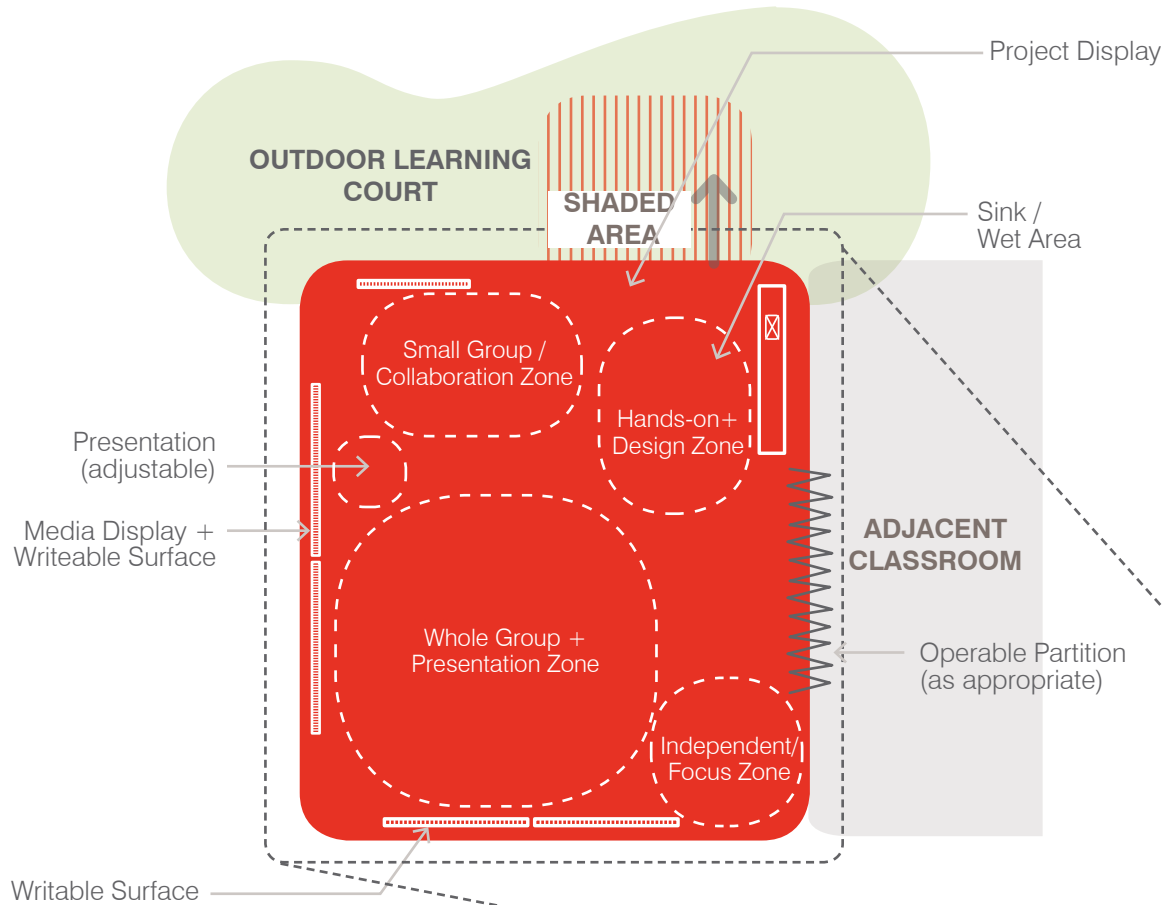
SPACE DIAGRAM

Group Classrooms together in 'pods' that open into a shared collaboration space.

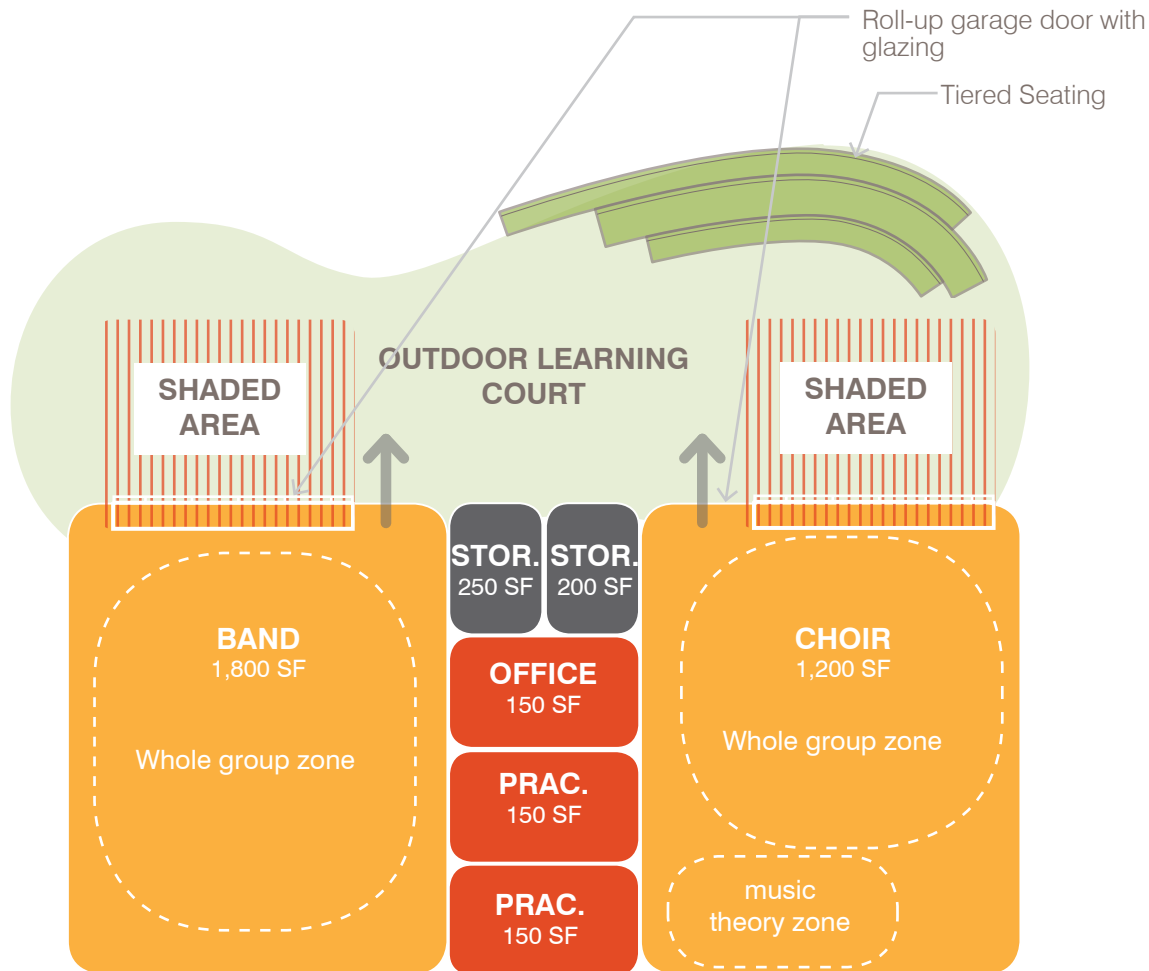
SPACE DIAGRAM

Music Labs can be grouped with classroom 'pods' to help build relevance in subjects. Alternatively Labs can be located near the Multi-purpose room for ease of access by all students.

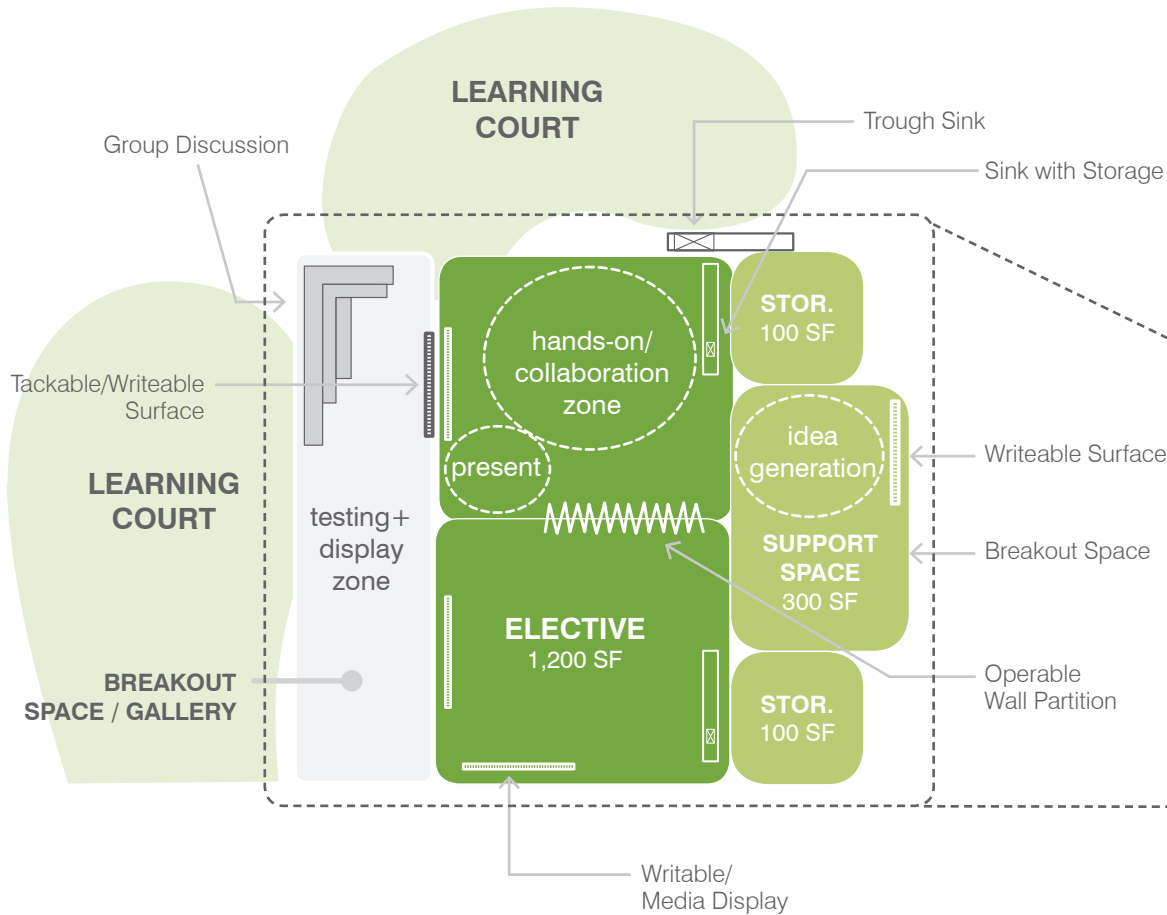
SPACE DIAGRAM

Cluster STE(A)M program classrooms together to facilitate integration of subjects and promote team teaching opportunities.

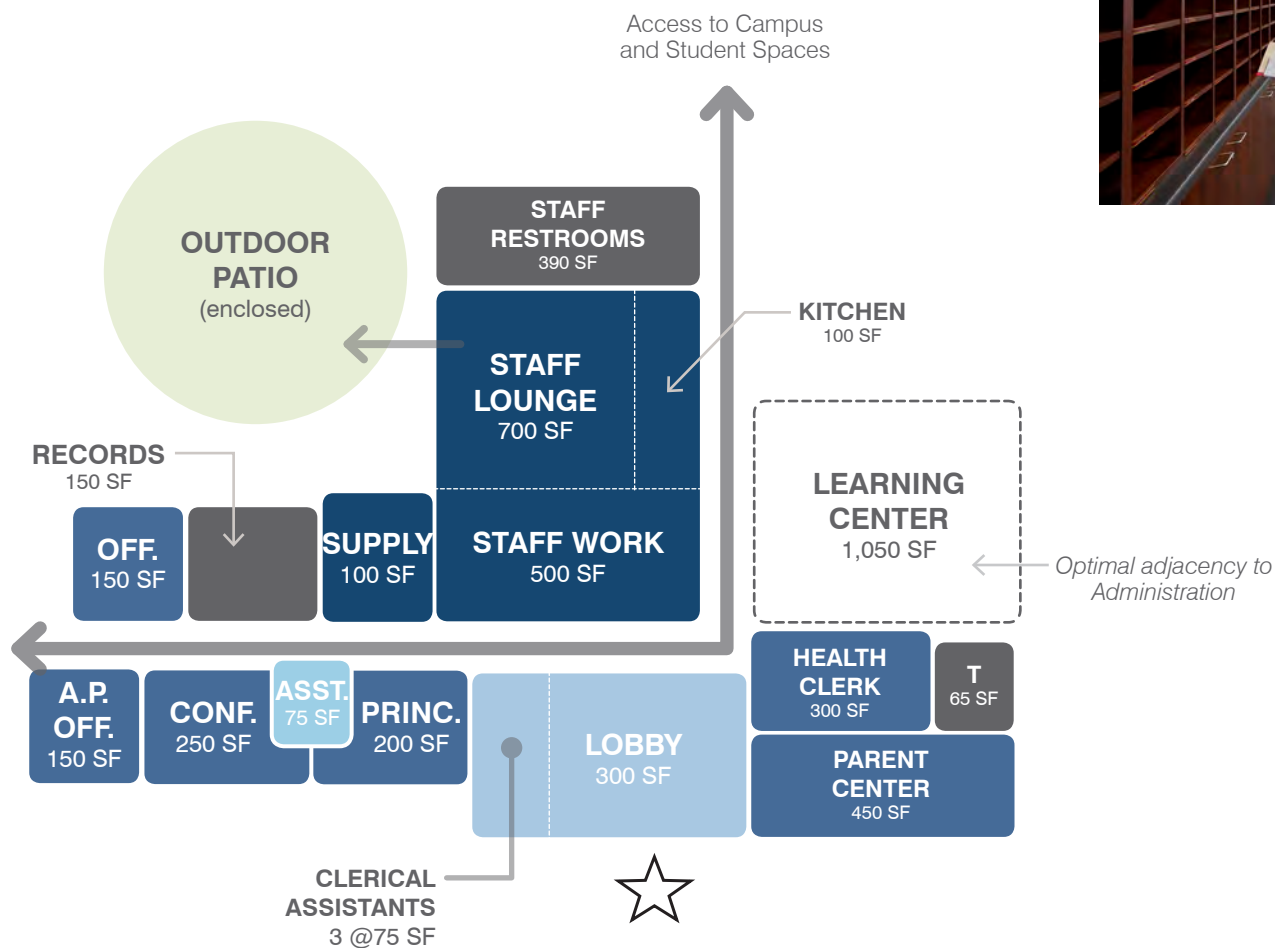
Administration building should be the main public entry of the school. Organize more 'public' functions (Parent Center, Health, and Conference Room) near the Reception/ Lobby area. Locate more 'private' functions (Offices and Staff Work) towards the interior.

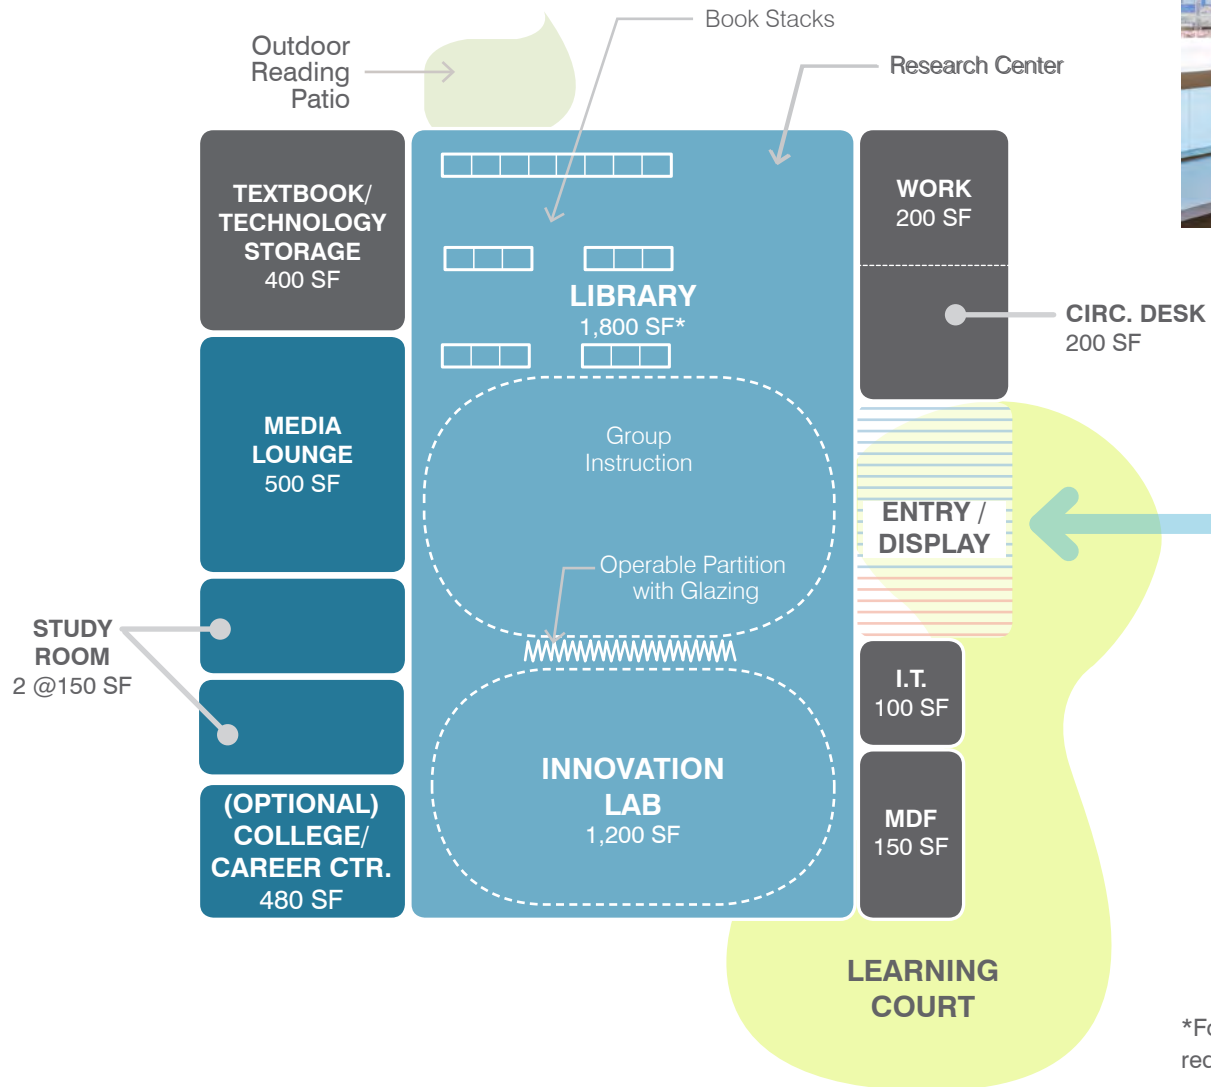
Organize the space to support multiple types of activities and sizes of groups. Design for ease of supervision.

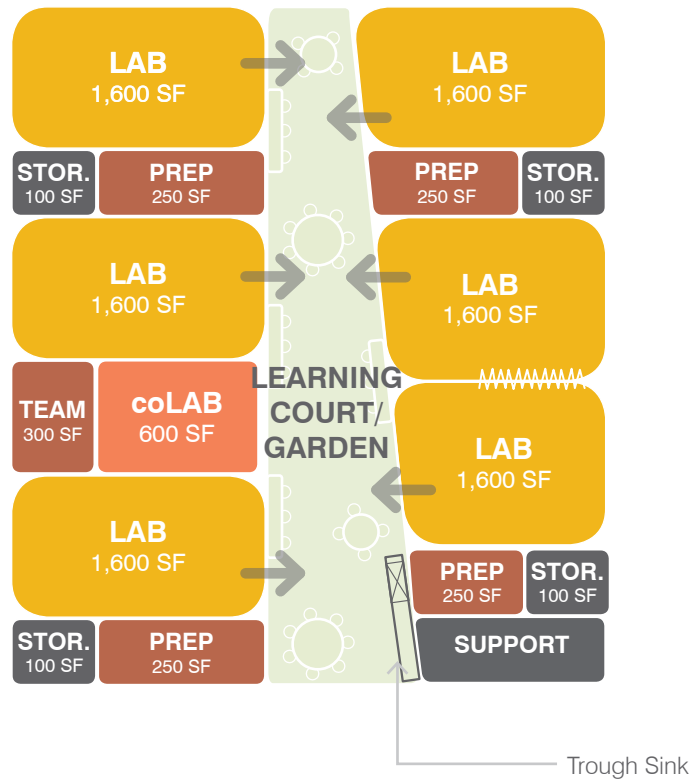
Group Science Labs together so that resources can be shared and utility connections can be designed efficiently. Cluster labs together to provide shared Prep Room areas and collaborative areas for students and staff. An exterior Learning Garden can provide an extension to the classroom learning environment.

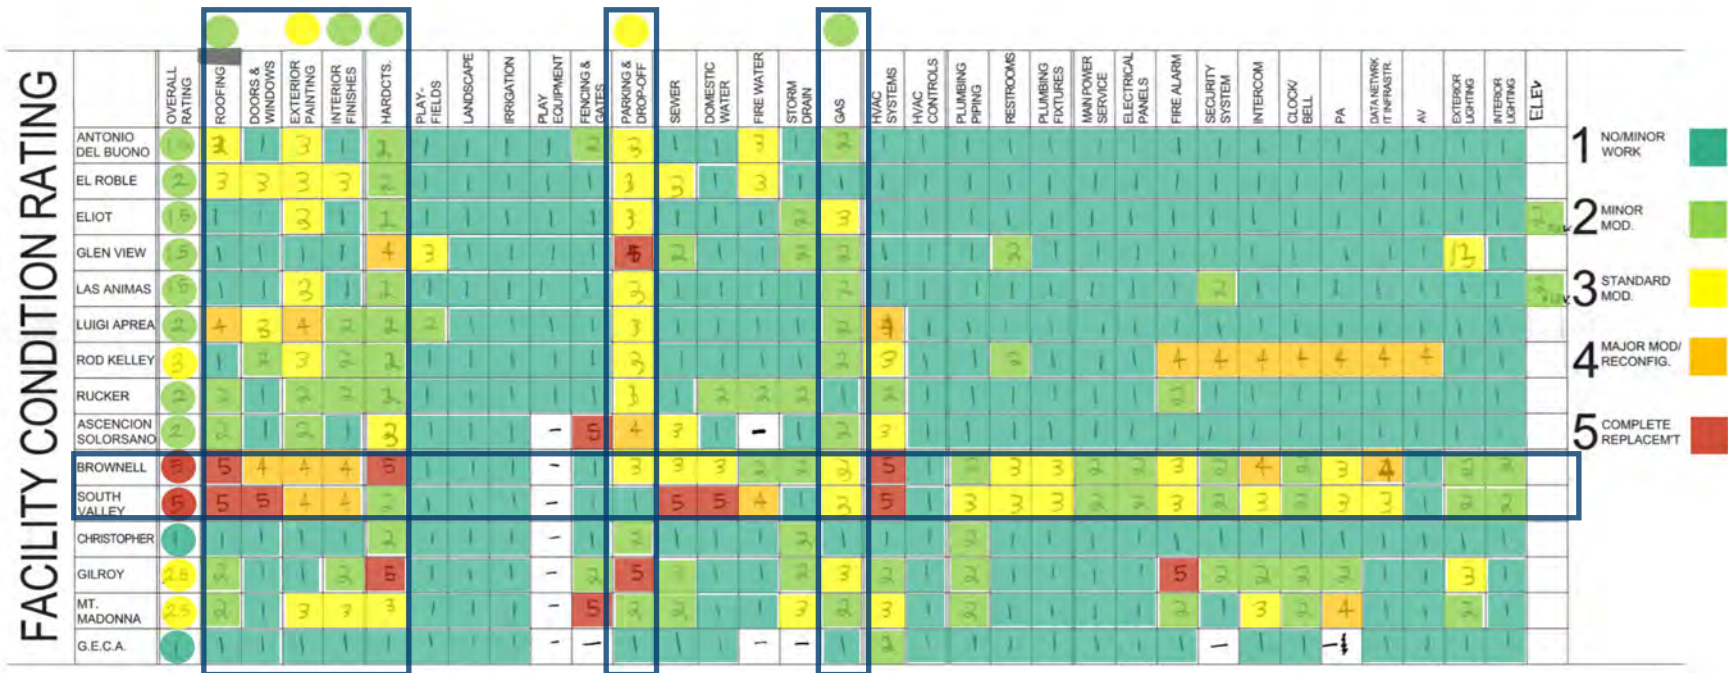
The following matrix is prioritization by Maintenance & Operations. The left column indicates school sites and the top row indicates areas of work. The priority and amount of work needed is correlated and is ranked on a 1 to 5 scale with 1 needing no/ minor work or low priority and 5 needing complete replacement or high priority. Looking at the prioritization by site, this matrix also illustrates the observation that the two sites with the highest need based on building condition are Brownell Middle School and South Valley Middle School.

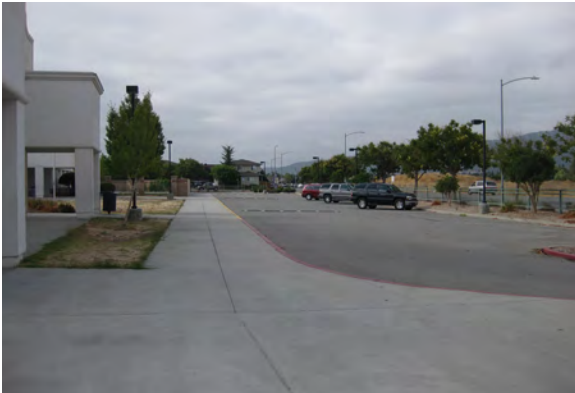
Parking and drop-off

- Parking lot AC paving need to be re-surfaced and re-striped.
- No ADA drop off zone; truncated domes missing.
- Signage missing at parking stall.(ADA)
- Signage missing at parking lot entrance.(tow-away)
- No ADA drop off zone.

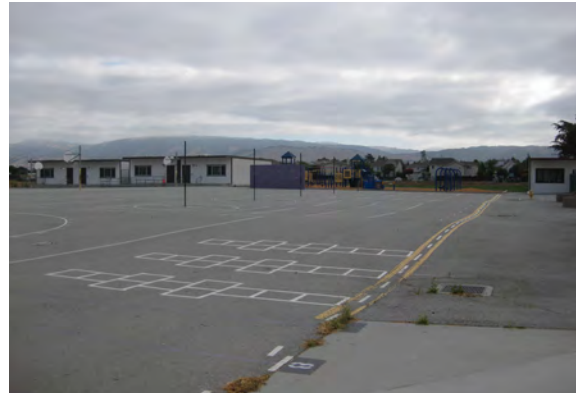
Hardcourts

- Hardcourts are relatively flat and in acceptable condition. Re-seal and re-stripe.

- Verify potential cross slope issues (>2%) at storm drain inlets.
- Various areas at the edges and near drains have cracking allowing water intrusion/ weed growth.

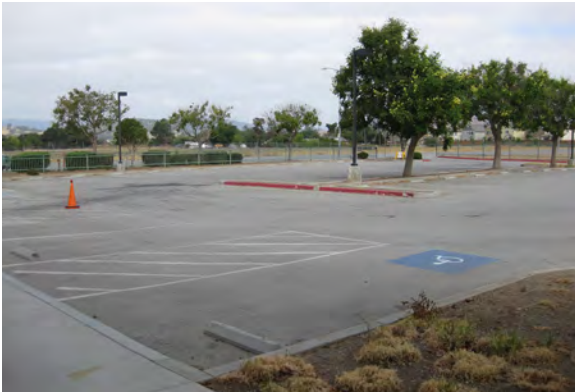
Staff parking lot

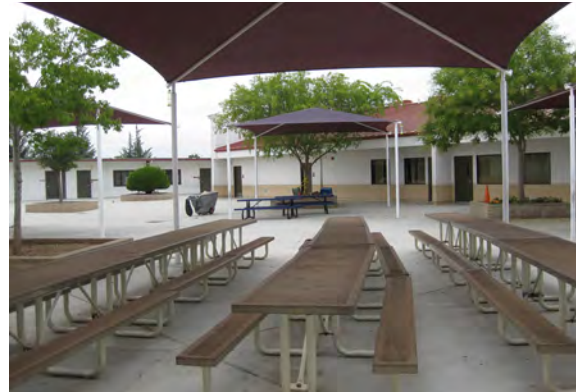
Shade structures / exterior student dining

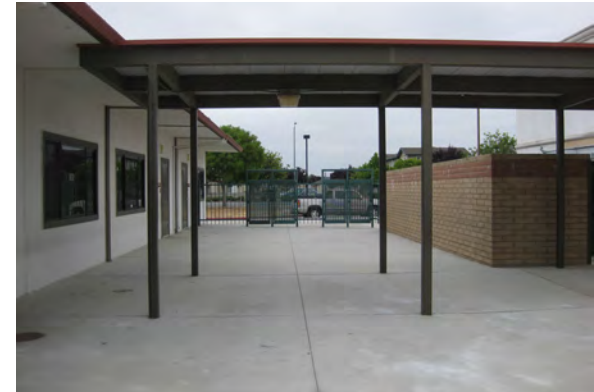
Typical covered walkway

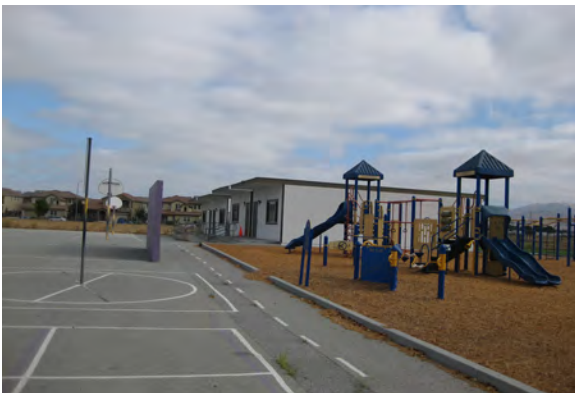
Play structure, hard courts and portable classrooms

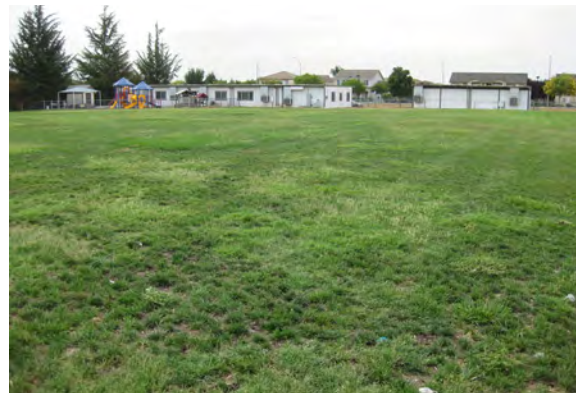
Playfields. Pre-school and after school portables in the background

- Interior drinking fountains appear to have hi-low and are accessible. Missing cane detection rails.
- Inadequate number of drinking fountains at the playfields. Principal noted some existing drinking fountains are not functional.

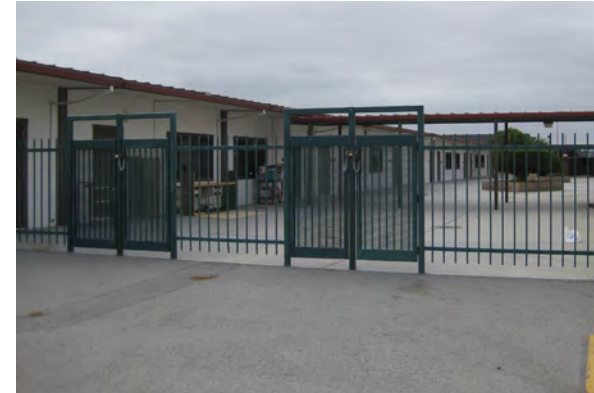
Typical steel ornamental fencing and gates

- Category [2]
- Fencing along the front of the campus is steel ornamental fencing.
- Fencing along the fields is chainlink.
- Current fencing along Farrell Avenue between the Pre-school portables are a 3'-0" high chainlink fence. This needs to be replaced with a 6'-0" high fence.
- Some areas are faded and in need of a new coat of paint.
- Some gates appear to be missing panic hardware and levers.

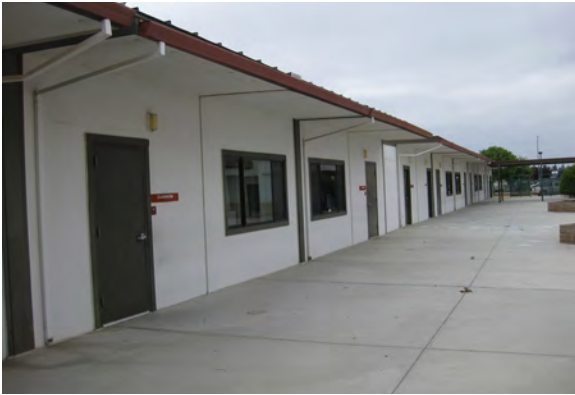
Modular classrooms

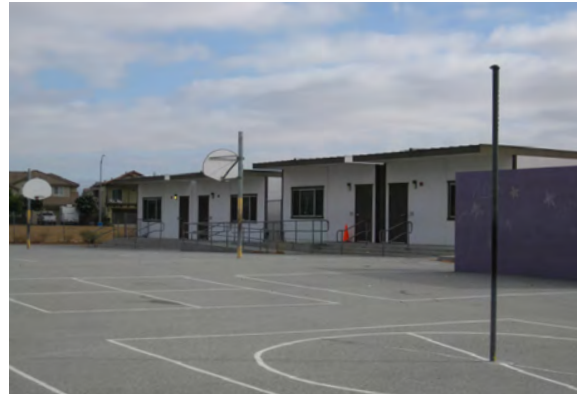
Portable classrooms, typical

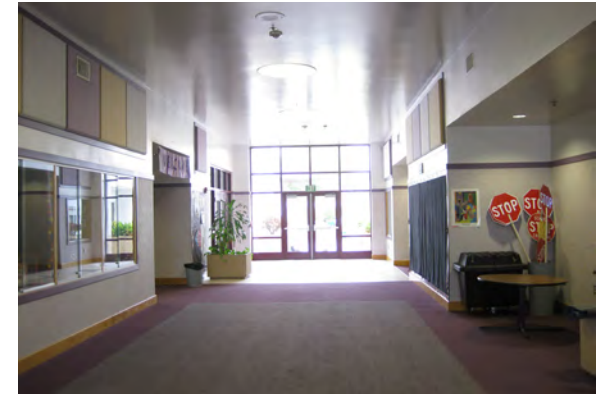
Main lobby / entry

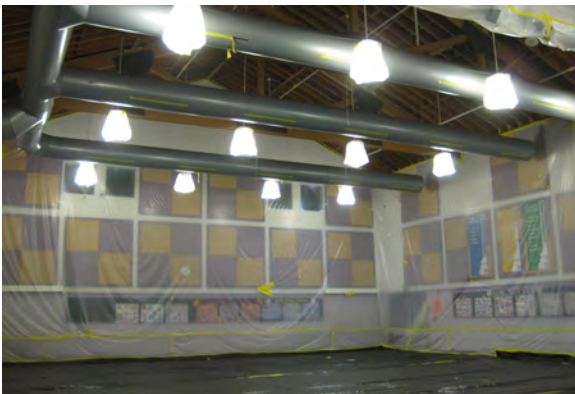
Multi-Purpose Room under repair

- Category [3]
- Roof is a standing seam metal roof. There have been separating issues at the MPR that are currently under repair.

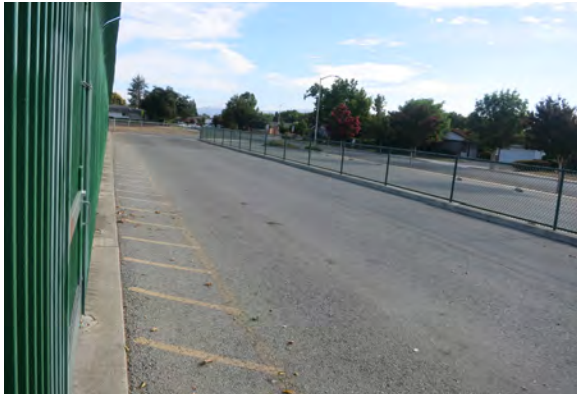
Drop-off zone

- Parking lot AC paving need to be re-surfaced and re-stripped. There have been some drainage issues.
- No ADA drop off zone; truncated domes missing.
- Signage missing at parking stall.(ADA)
- Signage missing at parking lot entrance.(tow-away)

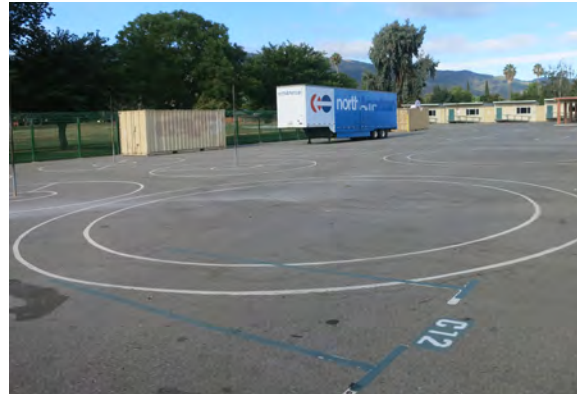
Typical AC paving at hardcourts

- Site AC paving is in poor condition with many areas of cracking that have allowed water intrusion/ weed growth. It needs to be re-paved.
- Paving at hardcourt area only, is in fair condition - re-seal and re-stripe.
- Paving where portable was recently removed needs to be re-finished.

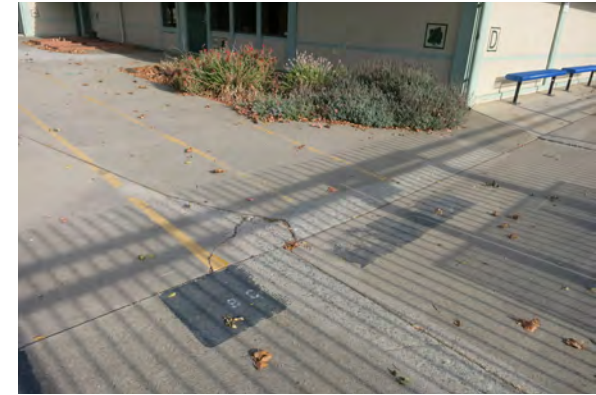
Typical concrete paving

- Concrete paving in general is in poor condition. There is cracking and uplifting at tree planter areas. Tree planters need to be replaced.
- Verify potential cross slope issues (>2%).

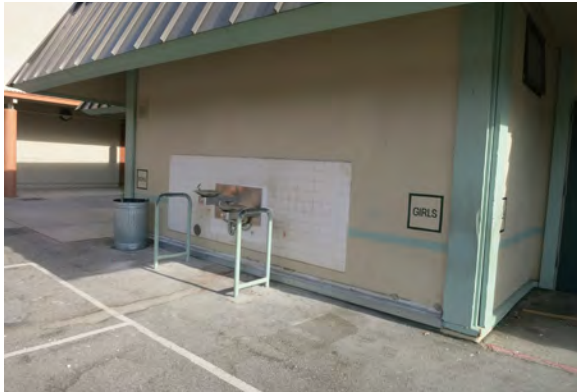
- Exterior drinking fountains have hi-low and are accessible with cane detection rails. Fixtures appear in good condition.

Typical drinking fountain

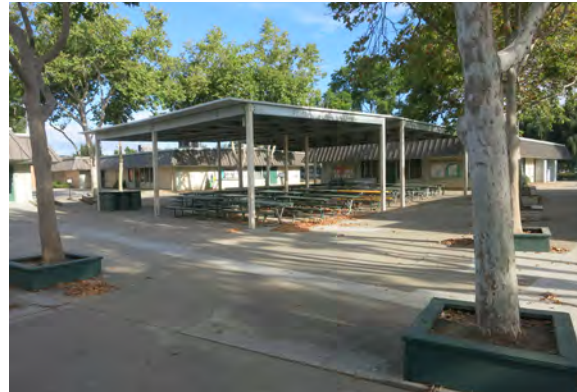
- Shade structure is a wood structure and it is in fair condition.

Wooden shade structures

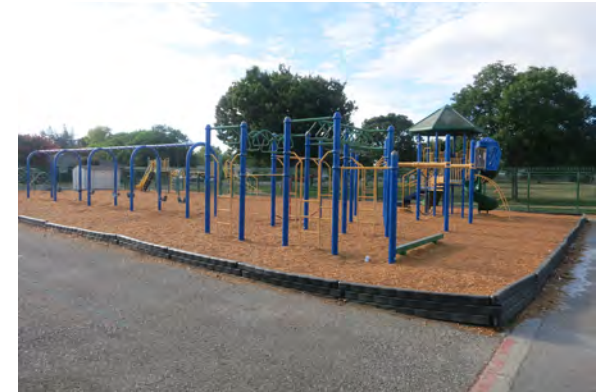
- Category [1]
- Play equipment in general is in good condition.
- Wood chips are in good condition.
- May be required to provide accessible access.
- Basketball backstops appear in good condition.

Play equipment

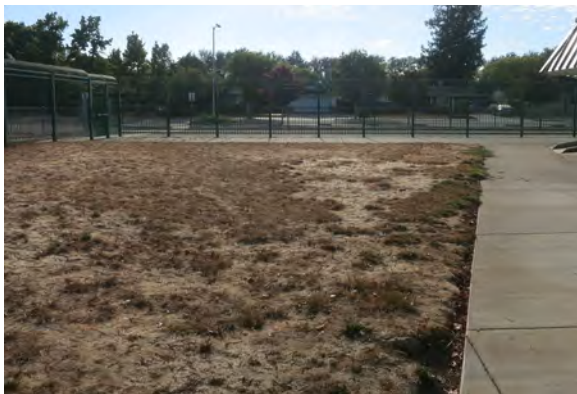
Typical landscape condition

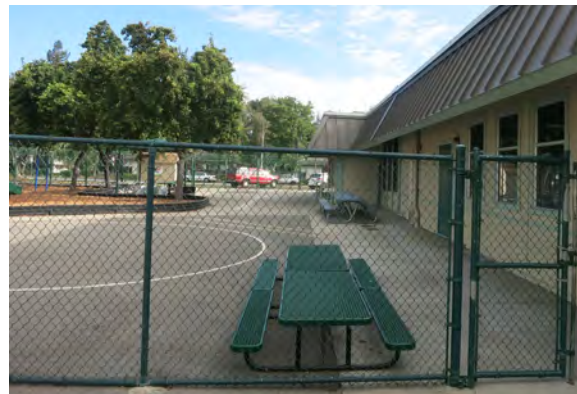
Interior site fencing

- Category [2]
- Most of the fencing is steel ornamental fencing and is in good condition.
- Chainlink fencing around the Kindergarten play yard needs to be re-evaluated to provide accessible gate access and security.
- Some gates appear to be missing panic hardware and levers.

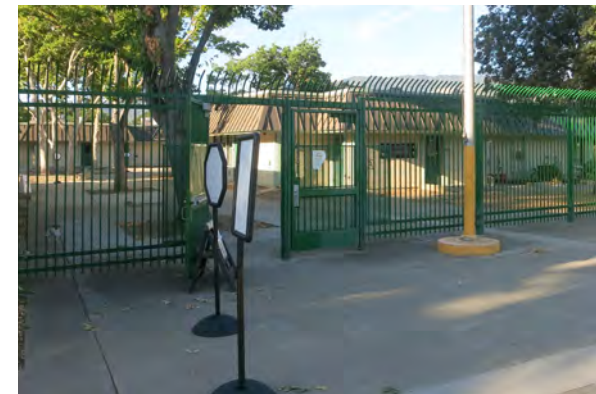
Perimeter site fencing

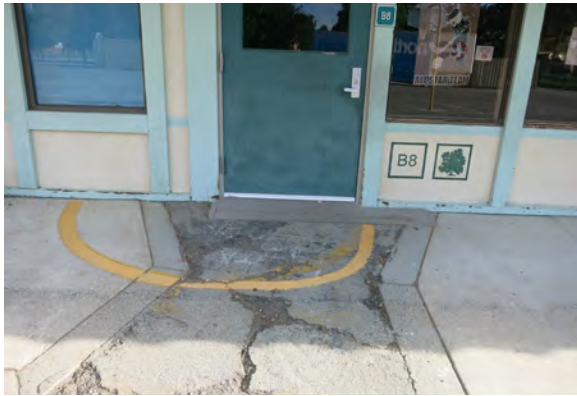
Exterior condition at doors and windows
