GILROY UNIFIED SCHOOL DISTRICT

FACILITIES MASTER PLAN

MARCH 2016

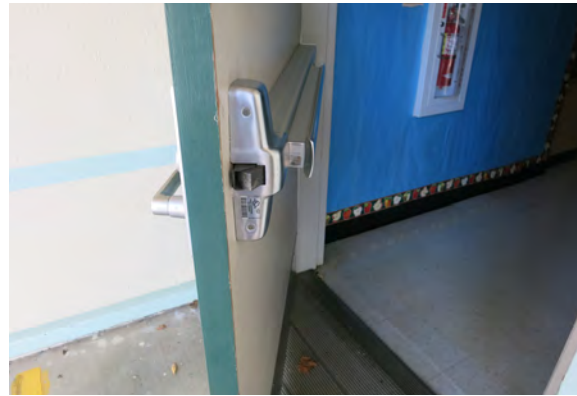
Exterior door hardware

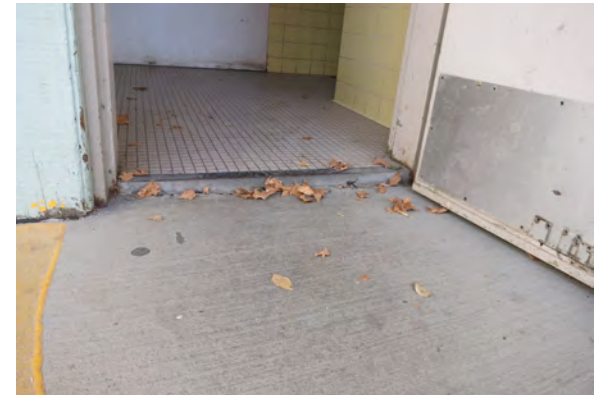
Threshold at restroom

- Category [2]
- Exterior doors are in fair condition. They need a new coat of paint. Various thresholds are not ADA compliant.
- Magnetic lock hardware have recently been installed.

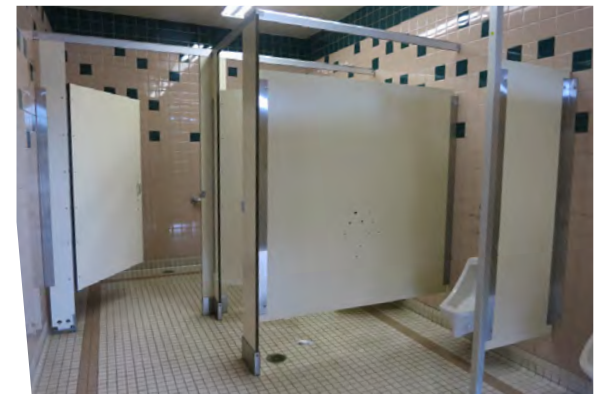
Restroom

- Category [4]
- Restrooms (except at the new MPR) have not been upgraded to meet accessibility requirements.
- Fixtures are in working condition.

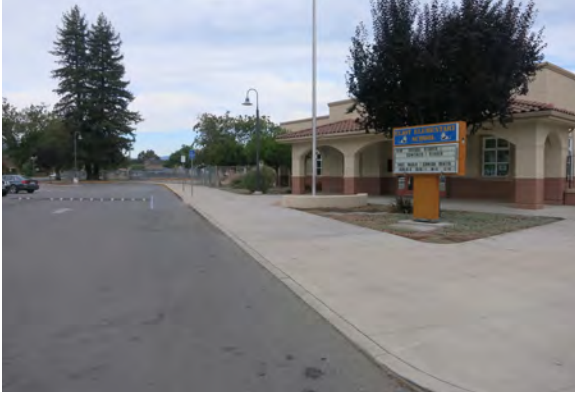
Drop-off zone

- Parking lot AC paving should be re-surfaced and re-striped.
- No ADA drop off zone; truncated domes missing at front drop-off and 7th Street pull-in.
- Signage missing at parking lot entrance.(tow-away)

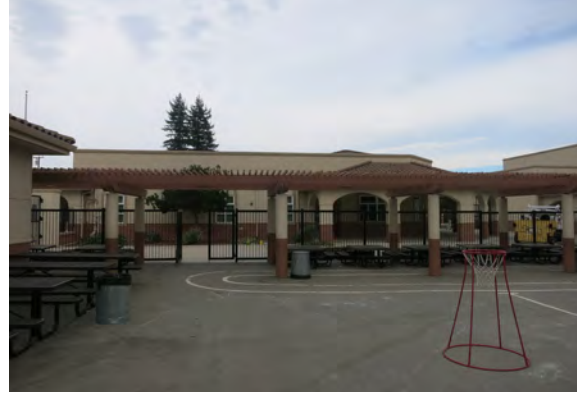
AC paving at Kindergarten play area

- Site AC paving is in good to fair condition. The Kindergarten play yard should be re-surfaced and re-stripped.
- Parking lot and hardcourts should be re-surfaced and re-stripped.

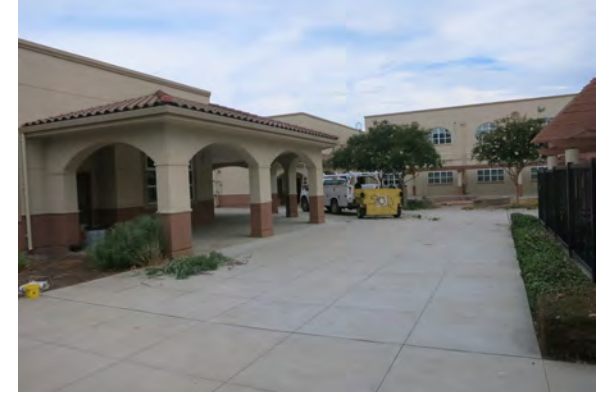
- Most of the campus is paved with concrete. Concrete paving is in good condition.

Typical concrete paving

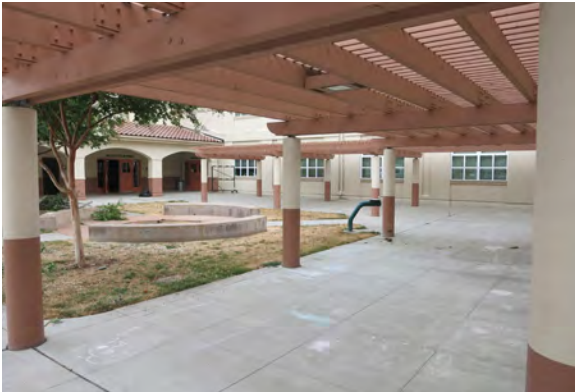
- Drinking Fountains
- Category [1]
- No issues noted.
- Shade Shelter
- Category [2]
- There are wood trellises that ring around the amphitheater that create shady dining areas. These are in good condition.
- The site would like additional shade structures at hardcourts.

Trellis structure at amphitheater

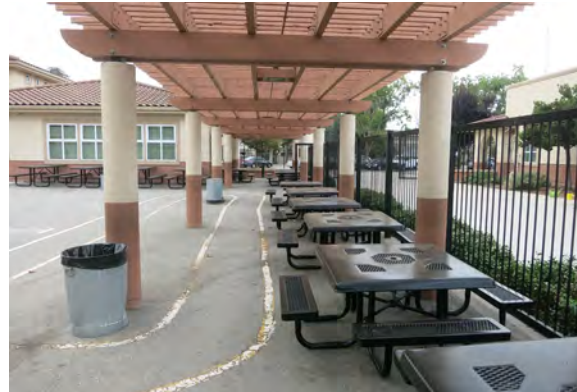
Trellis structure at Kindergarten

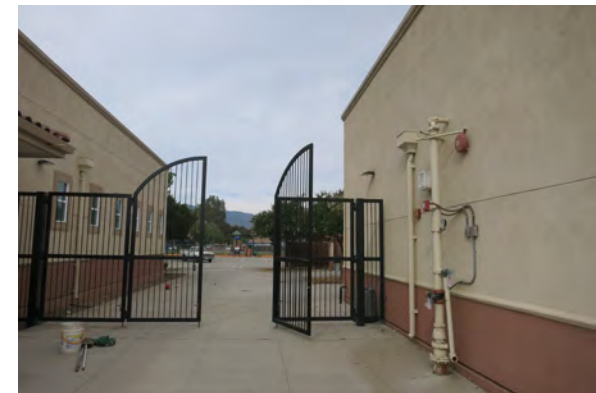
Perimeter fencing

- Some gates appear to be missing panic hardware and levers.

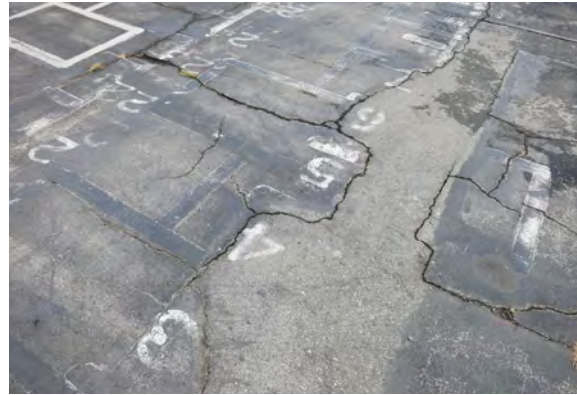
- Hardscape in general is in poor condition throughout the site.
- AC paving at hardcourts are in poor condition with large cracks and uneven pavement. Needs to be ground down and re-done.
- Potential cross slope issues (>2%) in various areas.

AC paving

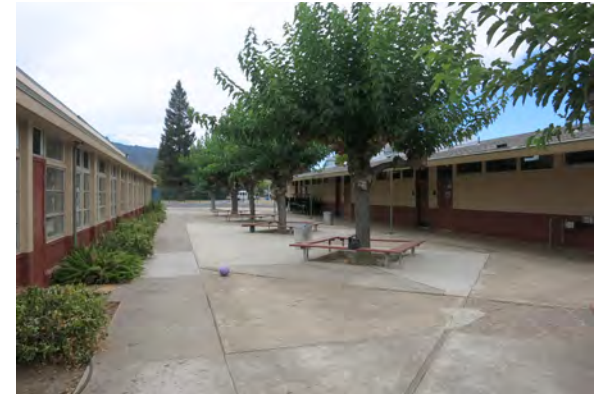
- Concrete paving in general is in good condition.

Concrete paving

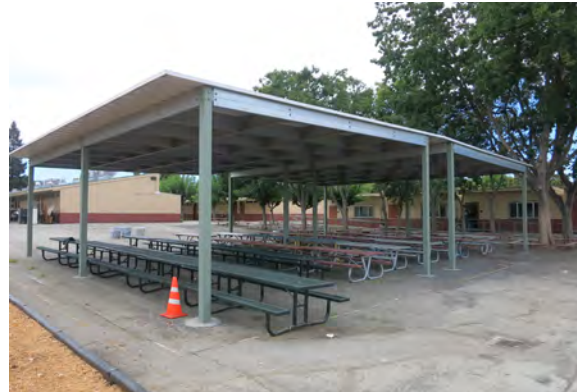
Shade structures

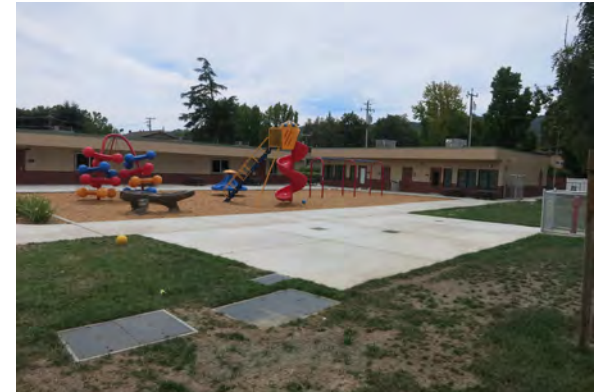
- Play equipment is in good condition; was installed in 2014.
- New Kinder play equipment is very high and poses safety concerns.
- Wood chips at main play structure and Kinder are in good condition.
- Basketball backstops and posts are in fair condition, new nets are needed.

Kindergarten play area

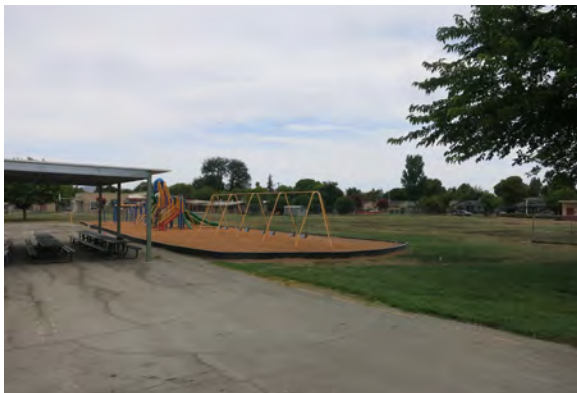
Play structure and fields

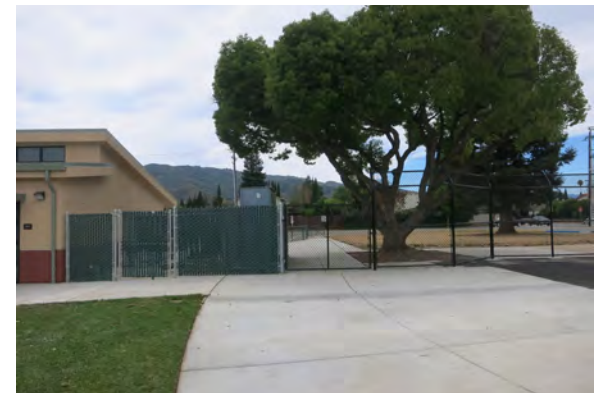
- Fencing is chainlink throughout the site and appears to be in good condition.

Perimeter fencing

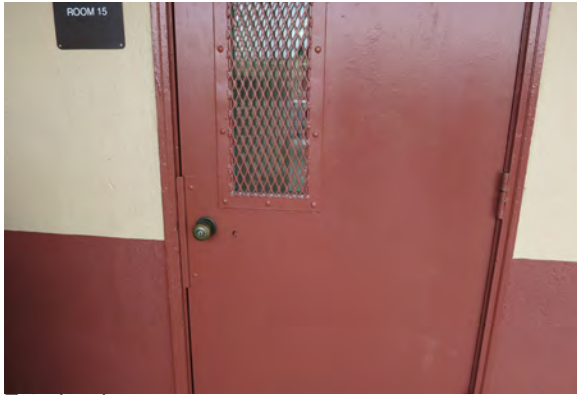
- Exterior doors are in good condition. They need

Exterior door

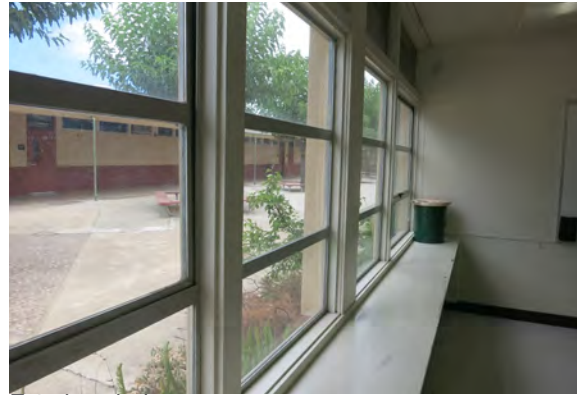
- Windows are in good condition.
- Windows at the old Building N are single pane and need to be replaced.

Exterior windows

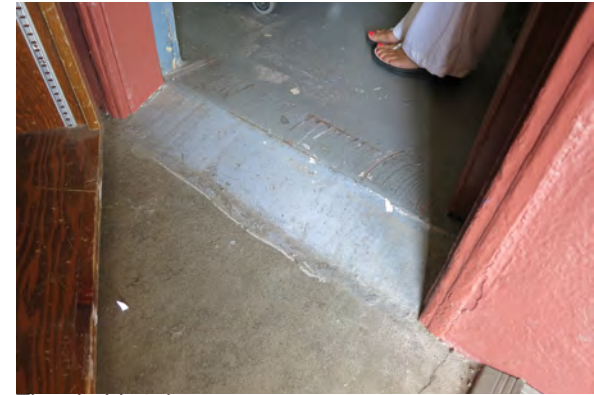
- Thresholds at the old Building N do not meet today's accessibility requirements. Doors also need to be replaced.
- Magnetic lock hardware have recently been installed (Summer 2015).

Threshold at doorway

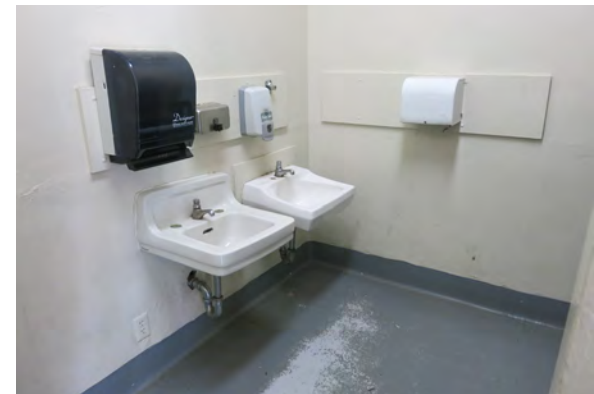
- Category [3]
- In general the restroom fixtures in the newer buildings appear in good condition. Restrooms meet accessibility requirements.
- The restrooms at the old Building N building are in poor condition and need a full modernization.
- Existing portable restroom East of the MPR is in poor condition.
- The MPR has waterless urinals which are not ideal. Replace with low flow urinals in future modernization work.
- Kinder toilets are new but are constantly getting clogged.

Restroom

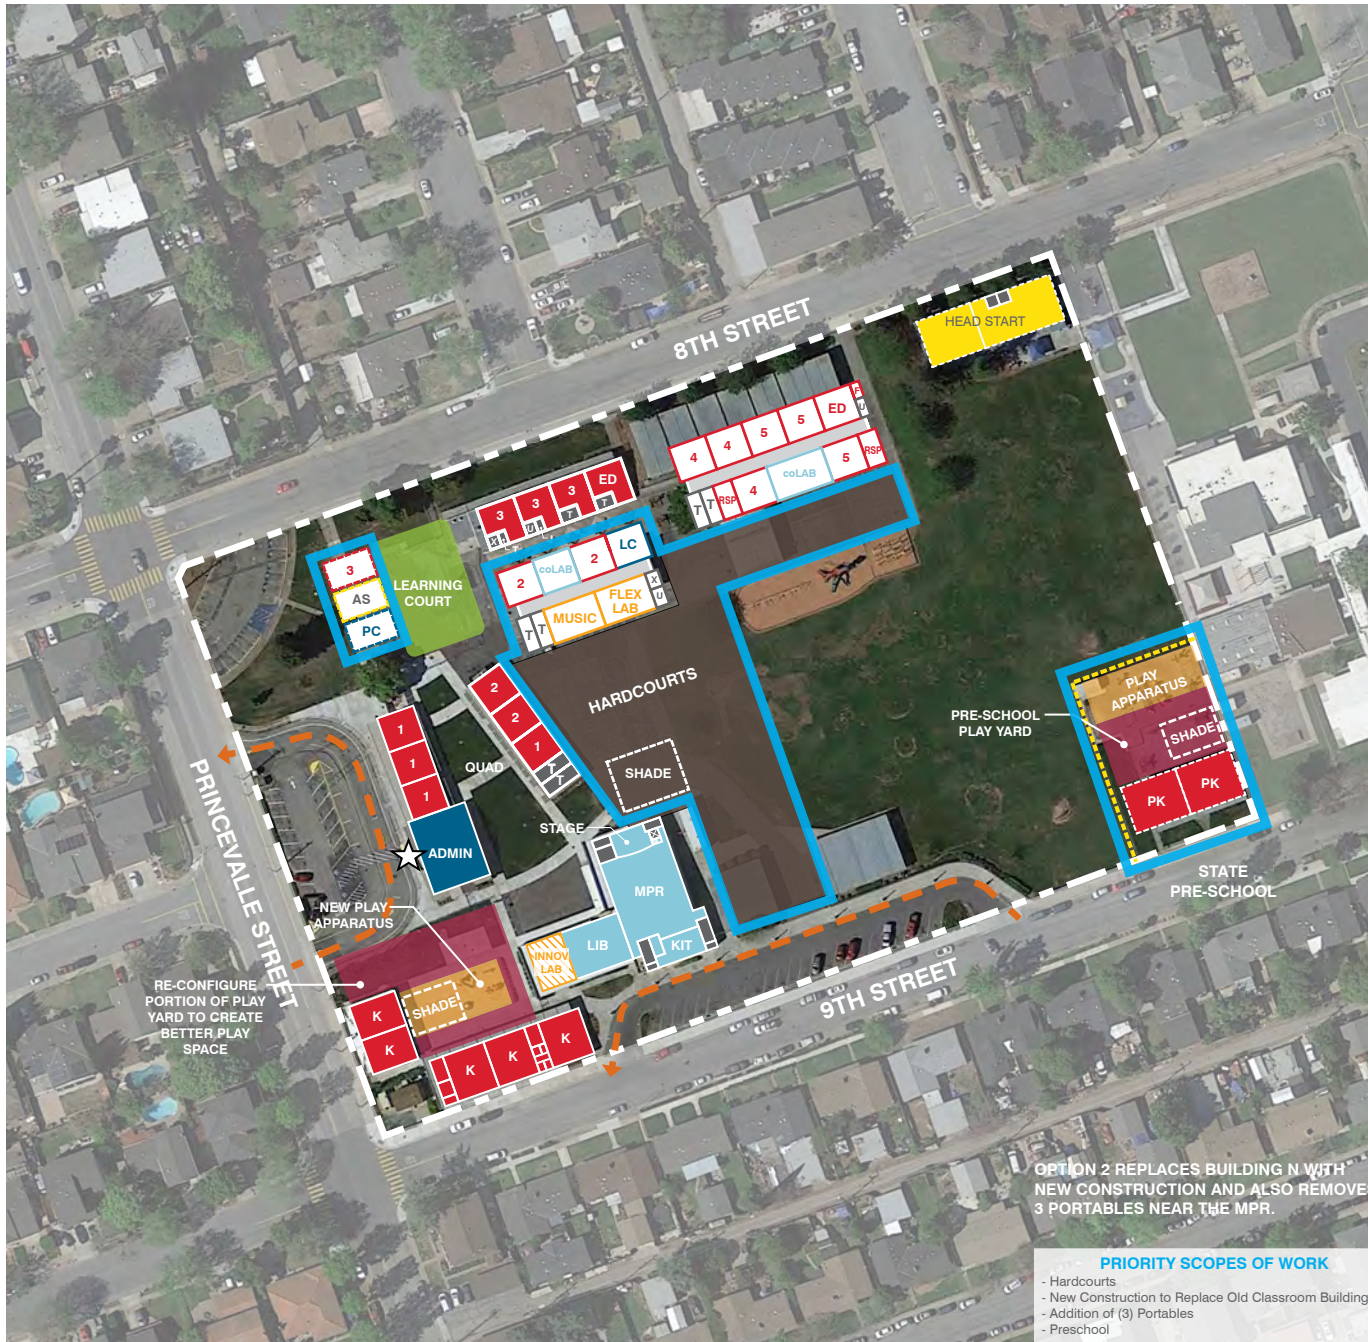
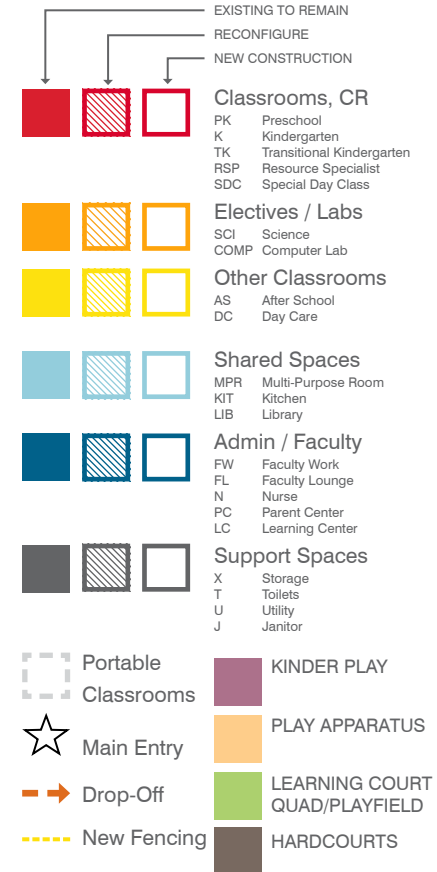
GLEN VIEW ELEMENTARY PROPOSED MASTER PLAN OPT 1

Planning Capacity:	566
Teaching Stations:	
Preschool, PK	0
Transitional Kinder, TK	0
Kindergarten, K	5
1 st - 3 rd Grade	12
4 th - 5 th Grade	6
Elective (1 - Flex, 1 - Music)	2
Innovation Lab	1
Special Day Class, SDC	2
Resource Specialist, RSP	2
After School	1
Other (2 - HeadStart)	2
Grand Total:	33

OPTION 2 REPLACES BUILDING N WITH NEW CONSTRUCTION AND ALSO REMOVES 3 PORTABLES NEAR THE MPR.

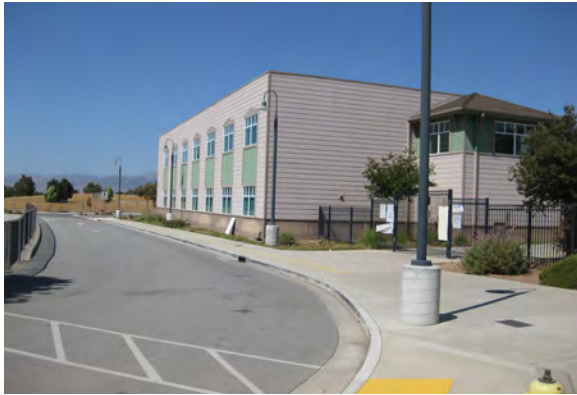
- Parking lot AC paving is in good condition and just needs to be re-surfaced and re-stripped.
- No ADA drop off zone; truncated domes missing.
- Signage missing at parking lot entrance.(tow-away)
- Drop-off doesn't work for both busses and parents. Conflict in the middle. Evaluate removing concrete paving at middle of drop-off to create 1 long drop-off.

Drop-off area

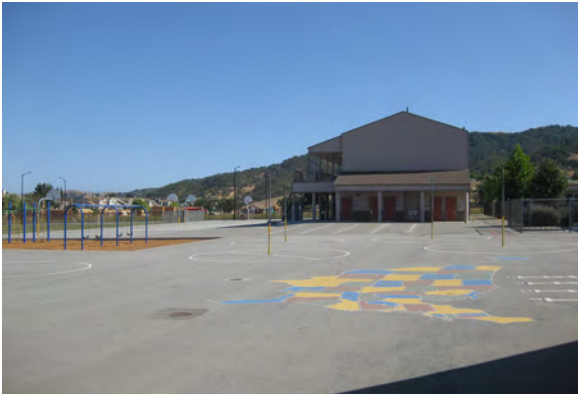
- Hardcourts are in acceptable condition. There is some cracking and weed growth at the edge along the playfield. Re-seal and re-stripe.

AC paving at hardcourts

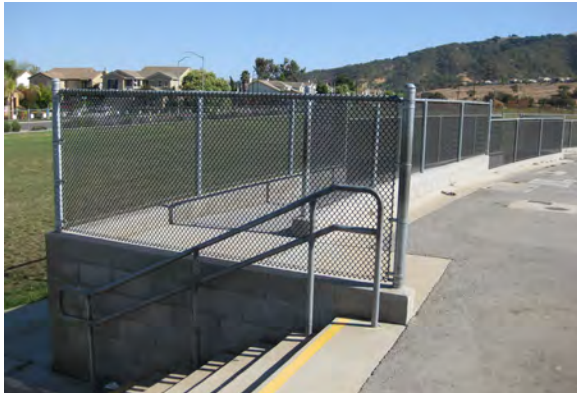
- Concrete ramp at playfield needs to be evaluated for accessibility. Appears to be missing intermediate landing.

Ramp and stairs to playfield

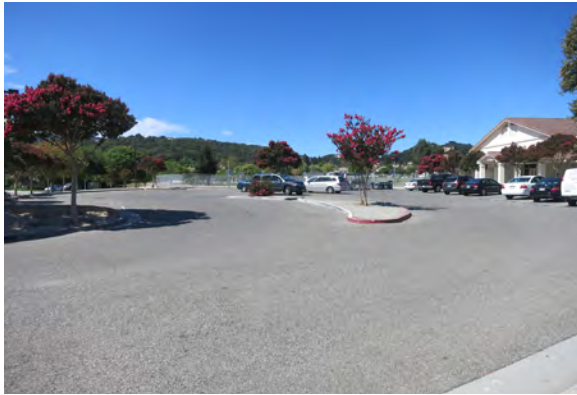
- Parking lot AC paving is in fair condition and needs to be re-surfaced and re-stripped.
- No ADA drop off zone; truncated domes missing.
- Truncated domes missing at ADA parking access.
- Signage missing at parking lot entrance.(tow-away)
- No ADA drop off zone.
- Special Ed bus drop off occurs on the street at Calle Del Rey. Parent drop-off occurs at on-site drop-off loop.

Parking area

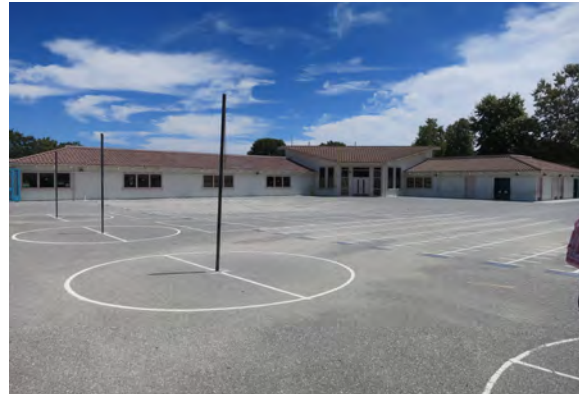
- Hardcourts are relatively flat and in fair condition. Re-seal and re-stripe.
- Verify potential cross slope issues (>2%) at portable ramps.

AC paving at hardcourts

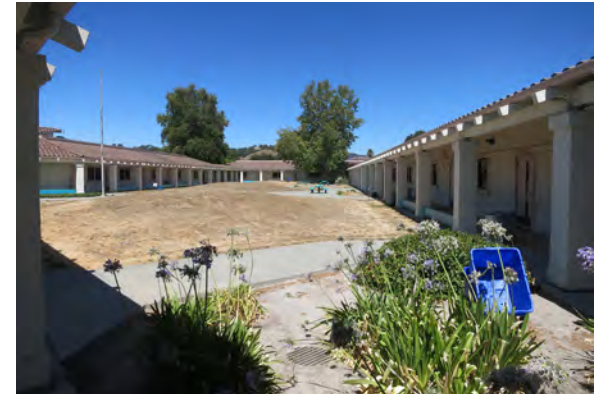
- Category [2]
- All grass landscape areas die in order to conserve water. Trees are still in place.
- Interior courtyard is in poor shape due to dying landscaped areas. Drought tolerant landscaping should be considered.
- Playfield is City owned and is in fair/ good condition.

Interior courtyard

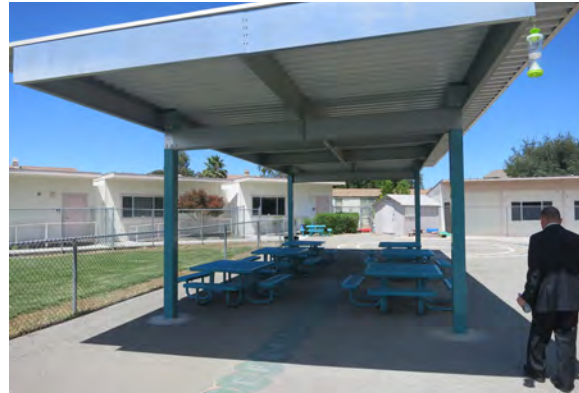
- Existing fabric type shade structures at hardcourt are utilized for lunch.
- Kinder has a permanent wood shade structure in good condition.
- Interior courtyard lacks shade. Desire for

Wood shade structures

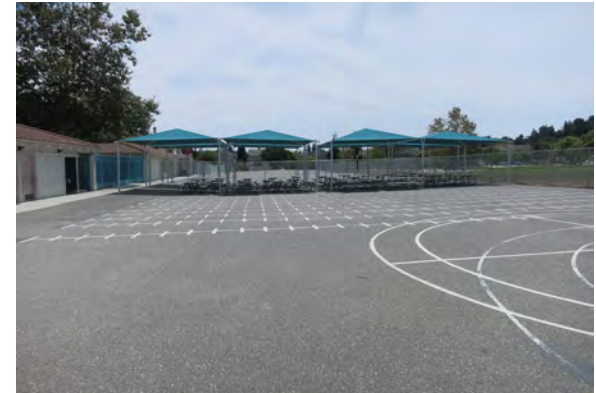
Fabric shade structure

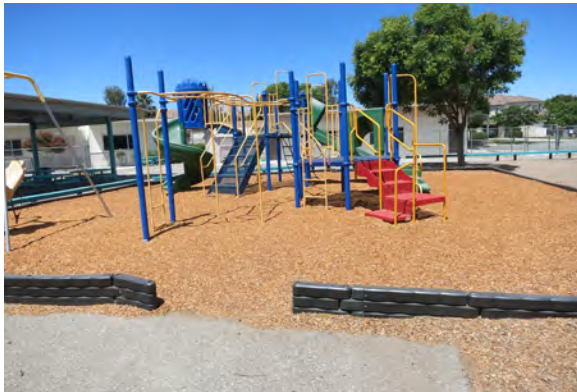
- Category [1]
- City play equipment is in good condition.
- Kinder play equipment in general is in good condition.
- Wood chips at play structure are in good condition.

Play equipment

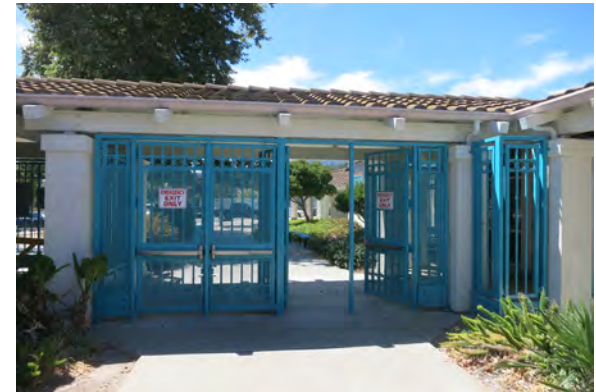
- Category [2]
- Fencing and gates are in good condition. Fencing along the front of the campus is steel ornamental fencing (put in 2014).
- Fencing along the fields and at Kinder is chainlink.
- Evaluate fencing layout at Kinder play yard vs. portables and fencing between basketball courts vs. City park to improve circulation.

Perimeter fencing

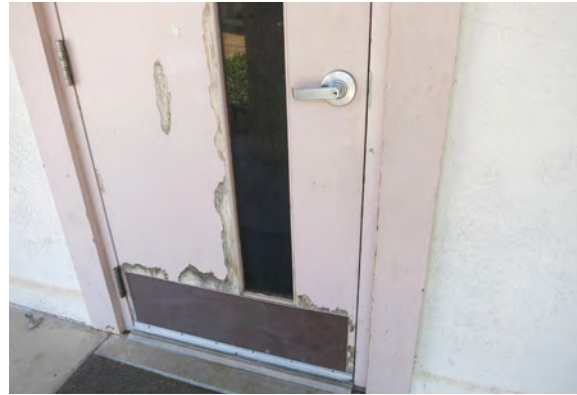
- Exterior doors are in poor condition. Some wood doors are deteriorating; all require new paint.
- Magnetic lock hardware have recently been installed (Summer 2015).
- Door thresholds need to be evaluated. They do not appear to meet today's accessibility requirements.

Typical exterior classroom door

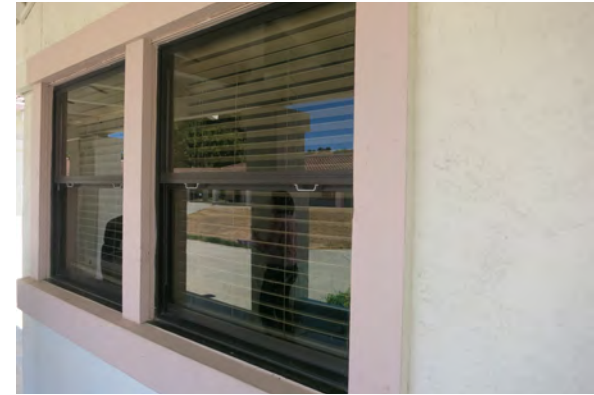
- Category [3]
- Windows are original, single pane. They are functional but should be replaced for energy efficiency.

Typical exterior window

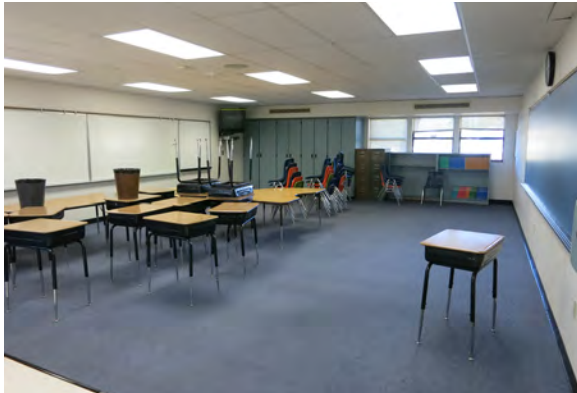
- In general, the interior finishes are in fair condition and is in need of a modernization.
- 2x4 suspended ceiling panels have staining in various areas. Carpets have some stains.
- Casework appears to be in good condition Classroom sinks need to be evaluated to check if they meet accessibility requirements.
- Room signage does not meets ADA requirements.
- The Principal noted that furniture is in disrepair and is in need of replacement.

Typical classroom

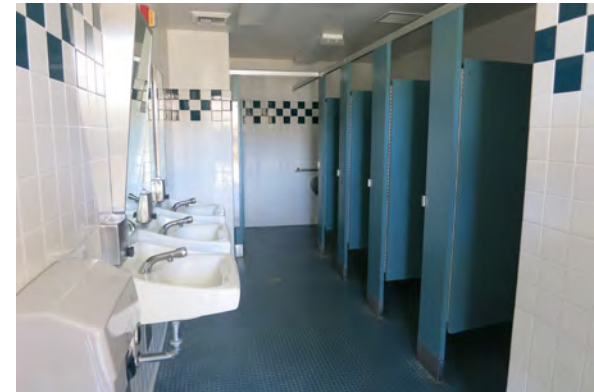
- Category [1]
- Restroom fixtures appear in good condition. Restrooms meet accessibility requirements.
- The kitchen has some minor maintenance issues that are being addressed.

Restroom

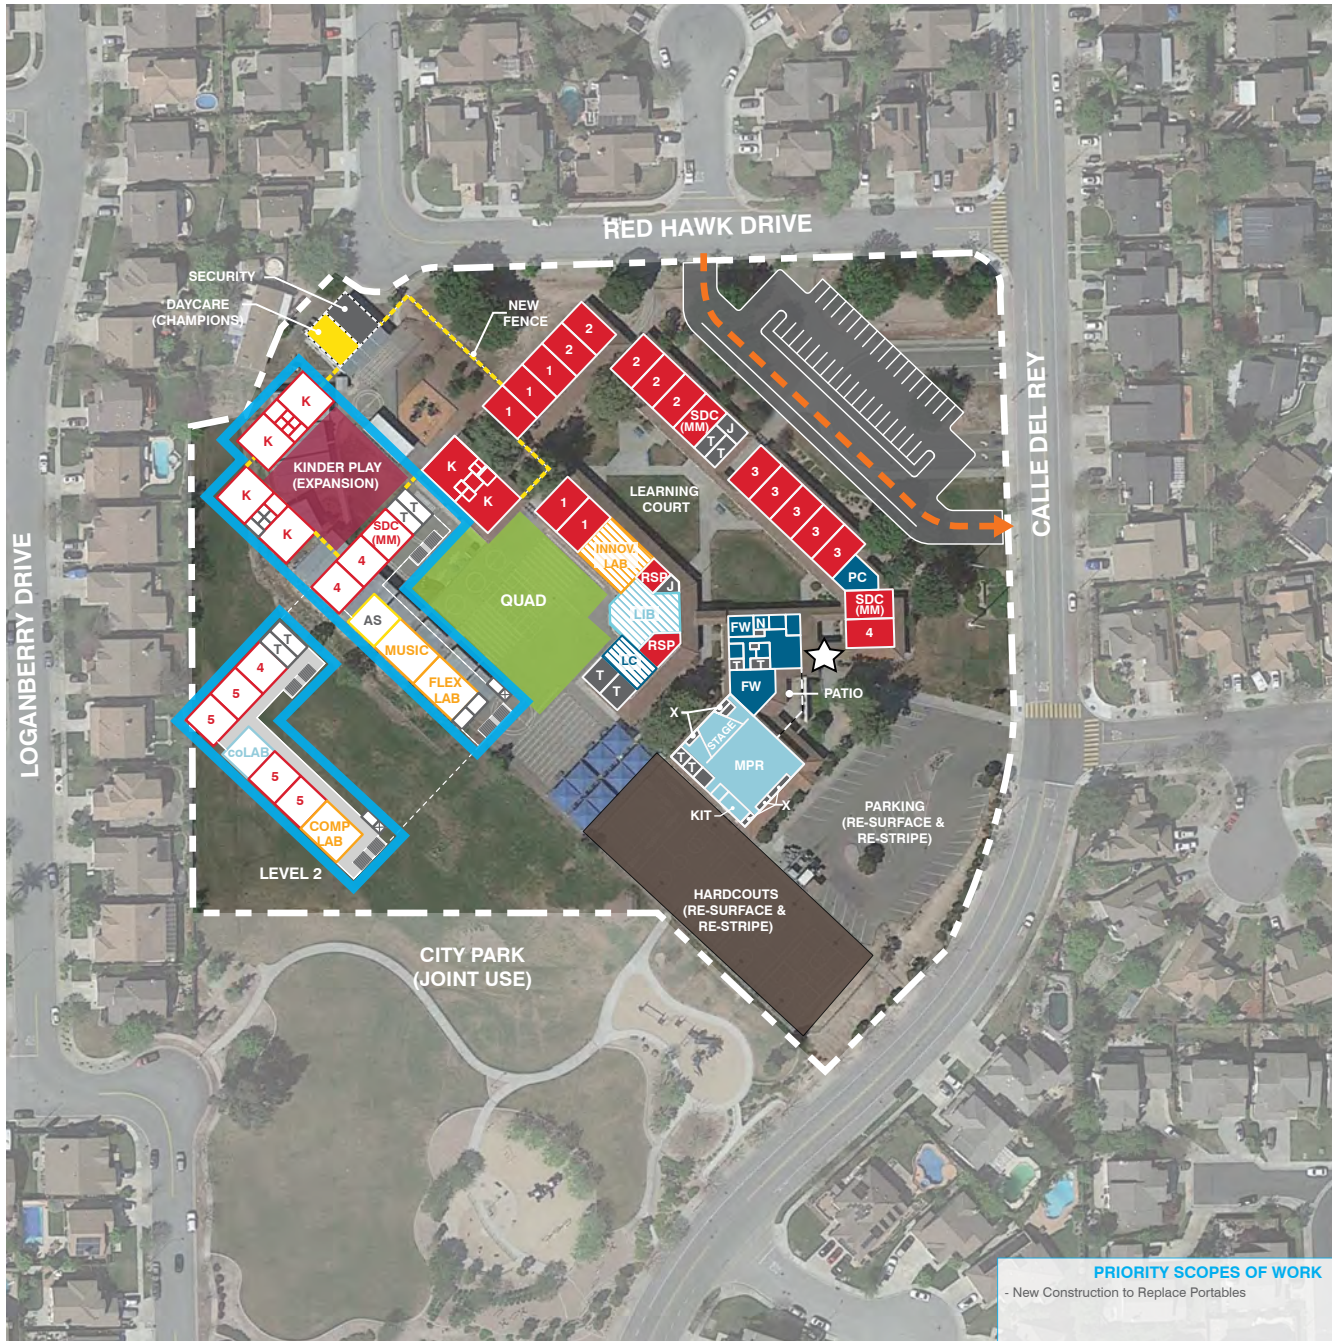
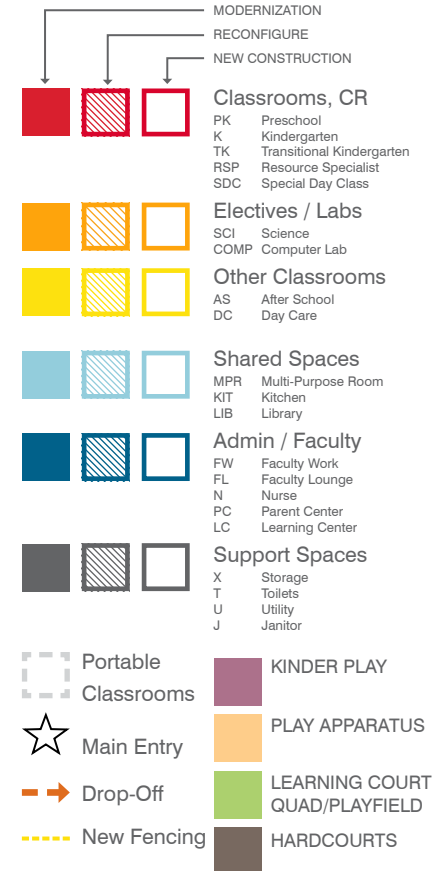
PRIORITY SCOPES OF WORK

- New Construction to Replace Portables

Planning Capacity:	696
Teaching Stations:	
Preschool, PK	0
Transitional Kinder, TK	1
Kindergarten, K	5
1 st - 3 rd Grade	15
4 th - 5 th Grade	8
Elective (1 - Flex, 1 - Music)	2
Innovation Lab (1 - Regular, 1 Innov. Lab)	2
Special Day Class, SDC (MM)	3
Resource Specialist, RSP	2
Other (1 - Daycare, 1 - Security)	2
Grand Total:	40

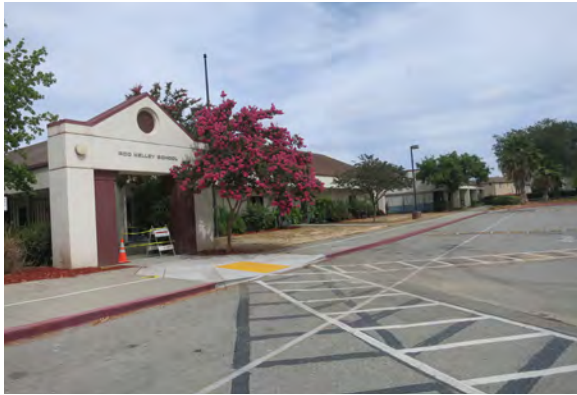
Drop-off area

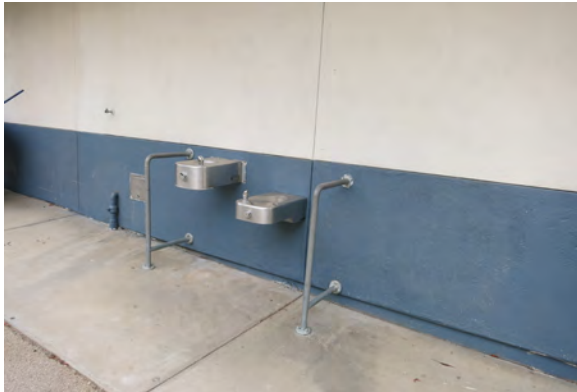
Drinking fountain

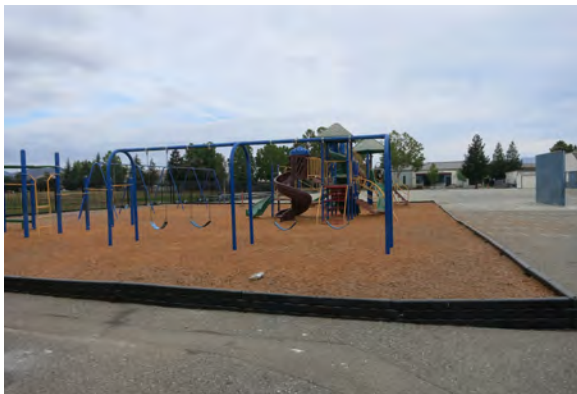
Play equipment

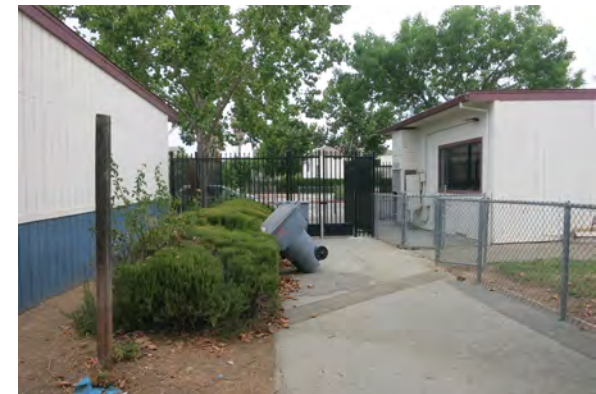
Site fencing

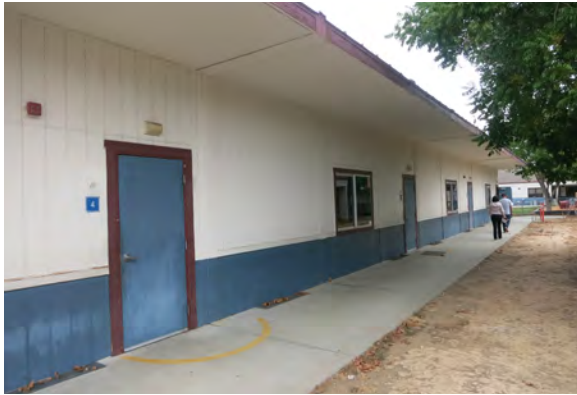
Exterior paint

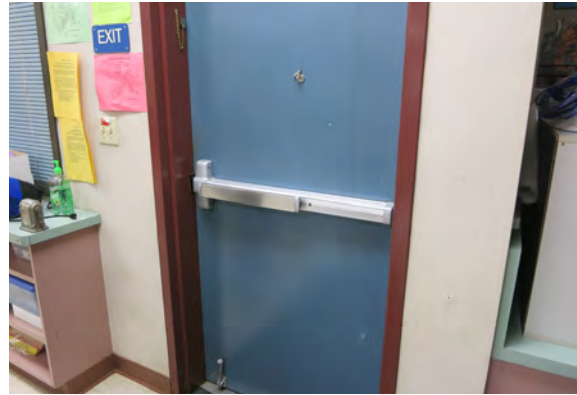
Exterior doors and windows

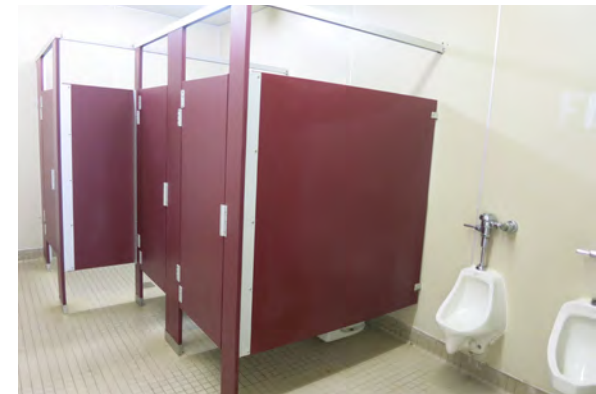
Restroom

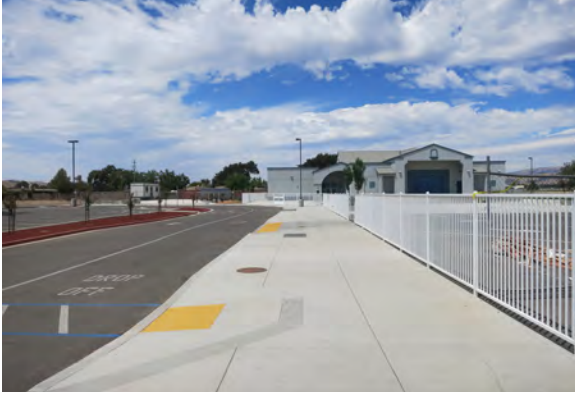
- Parking and drop-off have recently been re-done (2014) and are in good condition.

Drop-off area

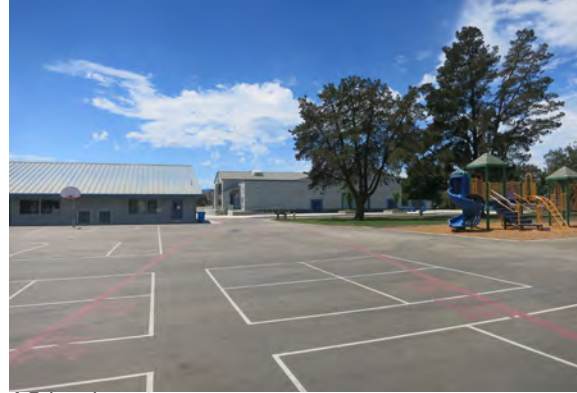
- Site AC paving in general is in good condition. Parking lot AC paving is in good condition. A

portion of the hardcourts at the tree court will be replaced Summer 2015. The basketball courts are in good condition.

AC hardcourts

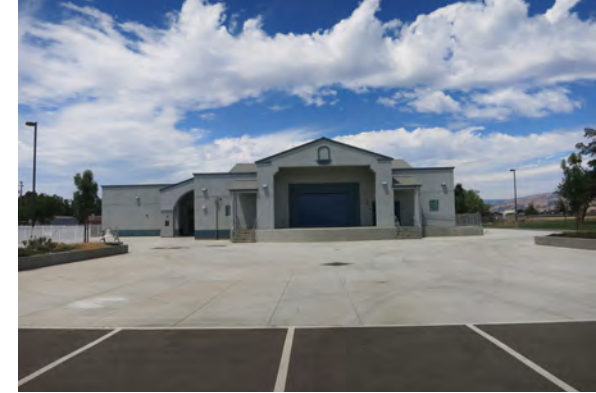
- Concrete paving in general, is in good condition.
- Walkways around Building 200-300-400 need to be evaluated for accessibility compliance. Portions need to be replaced.

Typical concrete paving and outdoor stage

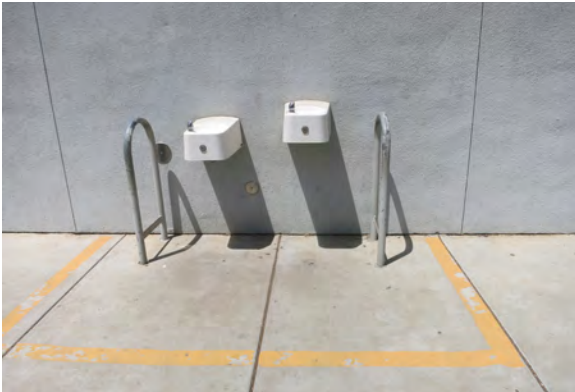
- Site drinking fountains have hi-low and cane detection rails. No major accessibility issues noted.

Drinking fountain

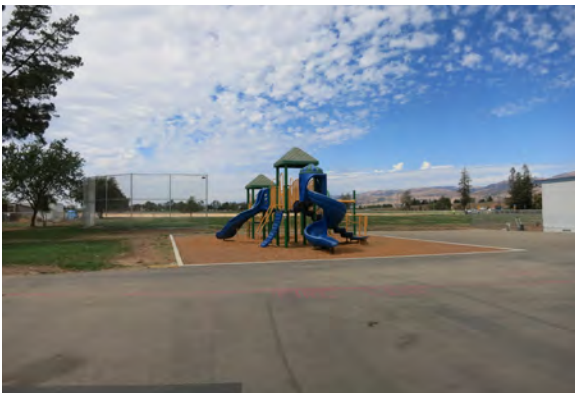
- Category [1]
- Play equipment in general is in good condition.
- Wood chips at the Kinder play yard could be added.
- Basketball backstops appear in good condition. Some basketball nets need to be replaced.

Play equipment

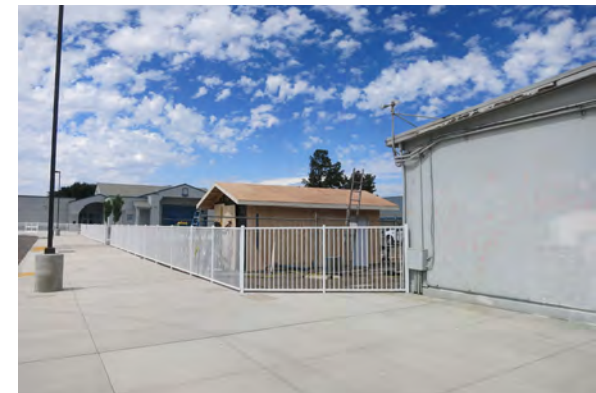
- Category [1]
- Most of the fencing along the front of the campus steel ornamental fencing and is in good condition.
- Chainlink fencing typical around playfields and back of site.

Perimeter fencing

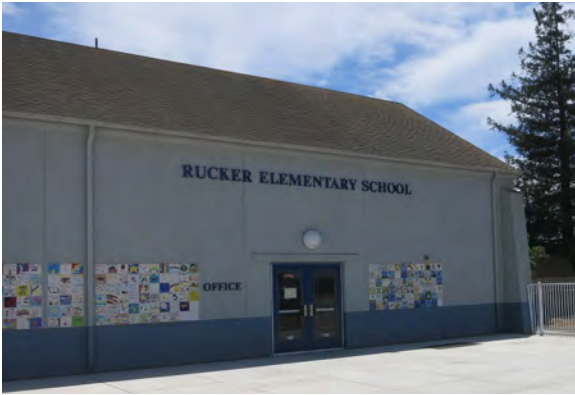
- Category [2]
- The newer buildings are in good condition.
- Building 200-300-400 will be painted soon (Summer 2015).
- Portables need a new coat of paint.

Exterior paint

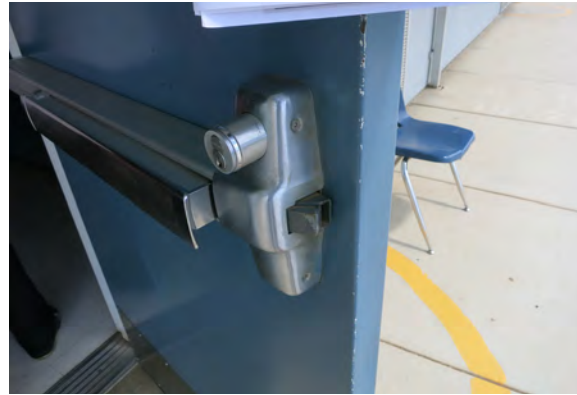
- Category [2]
- Exterior doors are in good condition.
- Door widths at the restrooms of the old 200-300-400 building are non-compliant and need to be replaced.

Exterior door hardware

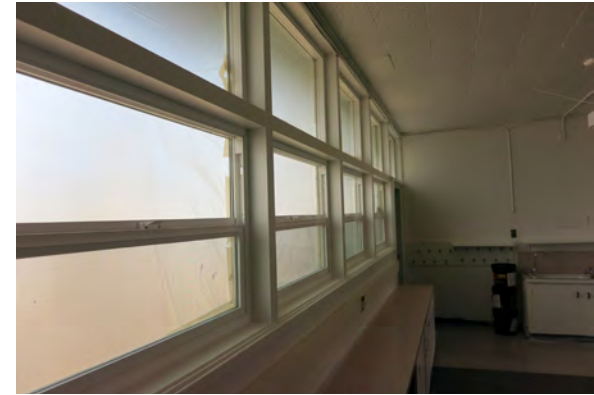
- Category [1]
- Windows are in good condition.

Windows

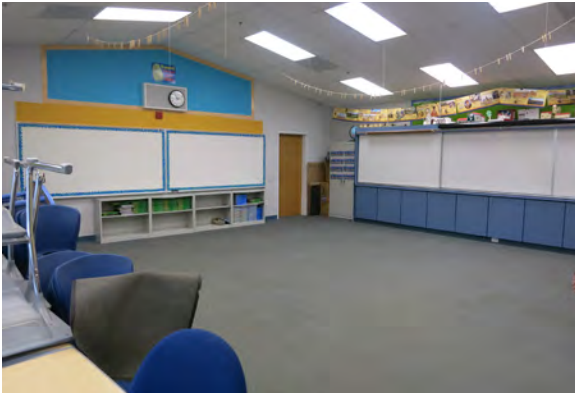
- The interior finishes are in good condition.
- Casework at the newer buildings are in good condition. Casework at Building 200-300-400 need to be replaced.

Typical classroom

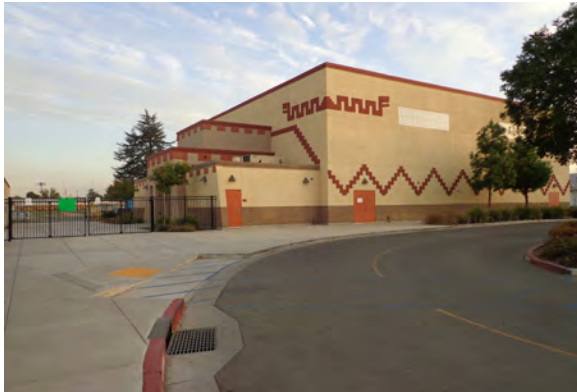
Gym

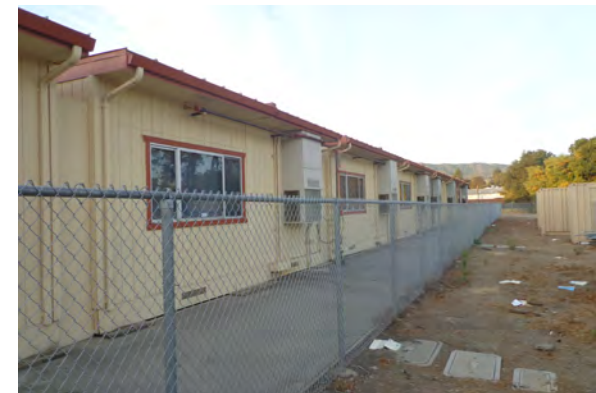
Typical portable Bard units

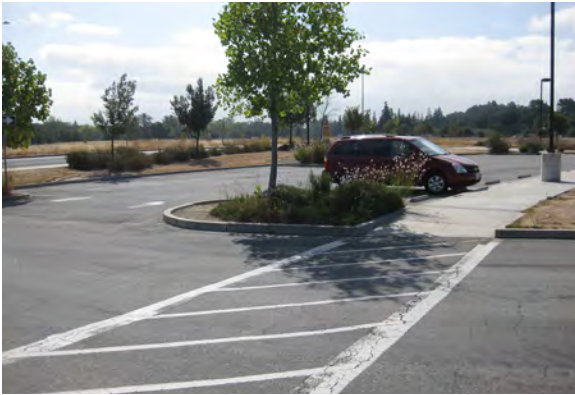
- Parking lot AC paving is in needs to be re-surfaced and re-stripped.
- The drop-off is functional for its purpose.
- No ADA drop off zone; truncated domes missing.
- Signage missing at parking lot entrance.(tow-away)

AC paving at parking area

- Hardcourts, parking lot and drop-of need to be patched/ repaired, re-surfaced and re-stripped.
- Fire lane needs to be re-done - cracking.

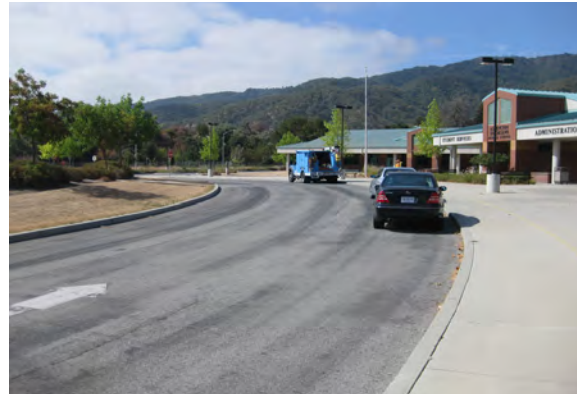
Drop-off area

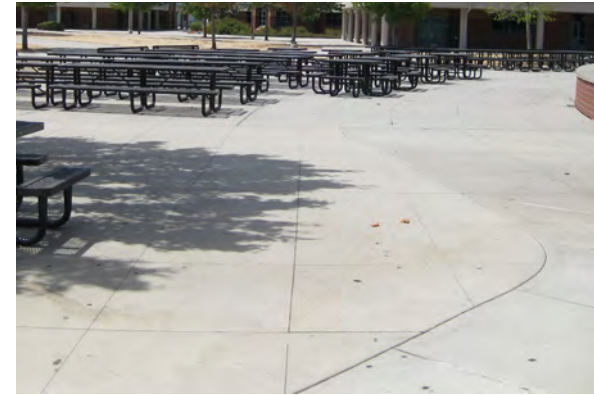
- Concrete paving in general is in good condition.

Typical concrete paving

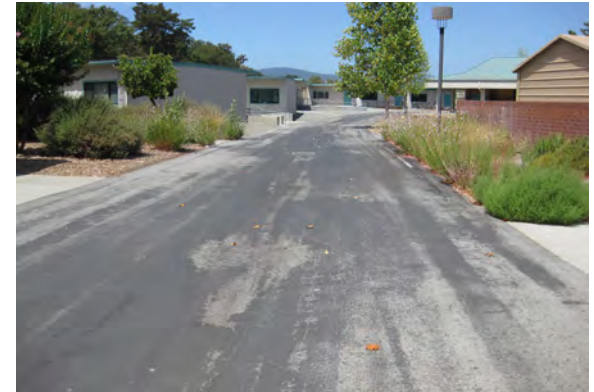
Fire lane

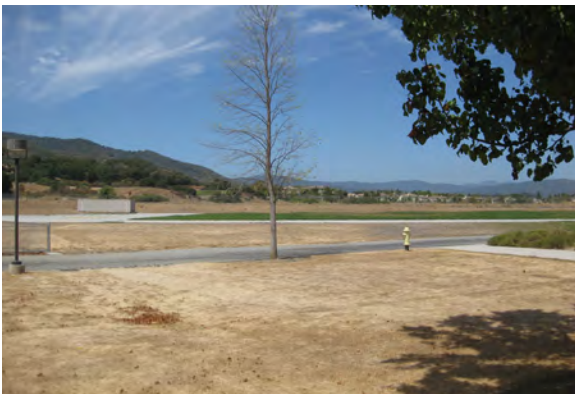
- Category [1]
- Landscape areas that are grass have been left to die to conserve water. The trees appear to be in good condition.
- The playfields are in good condition and are functional for its purpose.

Playfield (beyond)

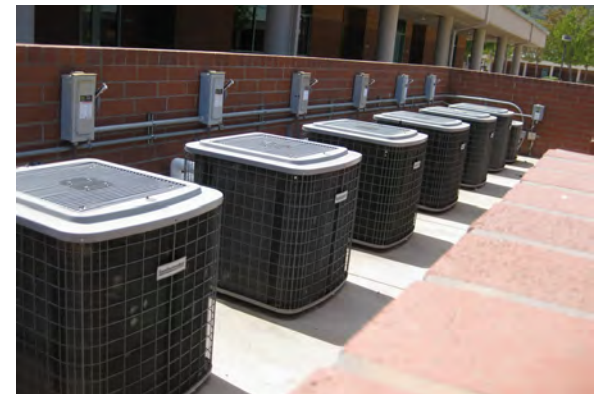
- Overall Rating: Category [3]
- The MPR / Kitchen / Gym have package units.
- Classroom buildings have split system.
- There are cooling issues with the condensers located too far from the units.
- Maintenance has been replacing ducts as needed. Condensate lines drip into ducts.
- Ducting and fire dampers in the 'S' building some are not functioning and need to be replaced.
- The site has EMS; controls are Allerton.
- Digital thermostats are typical in each Classroom.

Typical HVAC yard

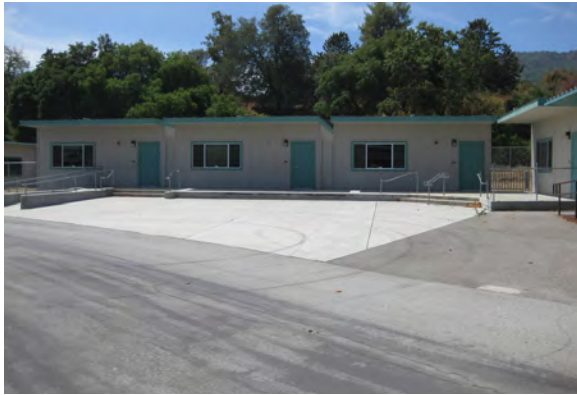
- Ramps at Portables - some are AC paving up to ramp, some are concrete up to door.
- Ramps at Portables are in fair condition. Railings need to be re-painted.

Portables exterior

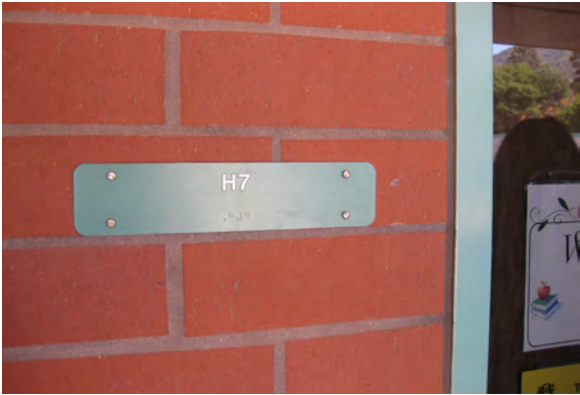
- In general, the interior finishes are in good condition.
- Casework appears to be in good condition. Classroom sinks meet accessibility requirements.
- Room signage appears to meets ADA requirements.

Typical classroom signage

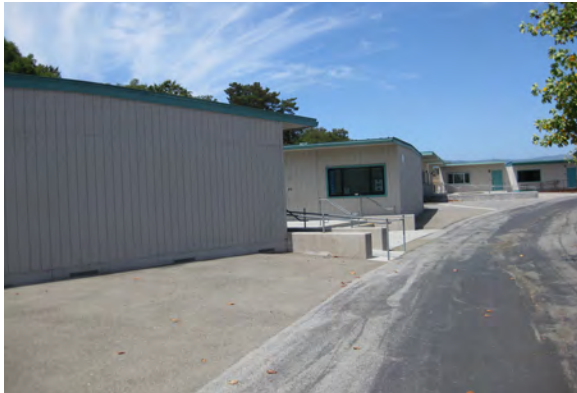
- Category [2]
- Building paint is in good condition.

Exterior paint conditions

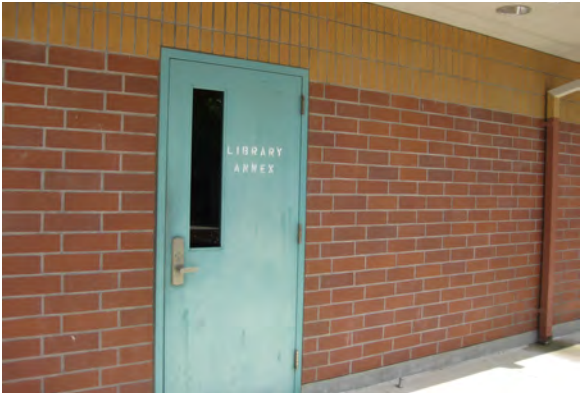
- Category [1]
- Exterior doors are in good condition. They could

Exterior doors

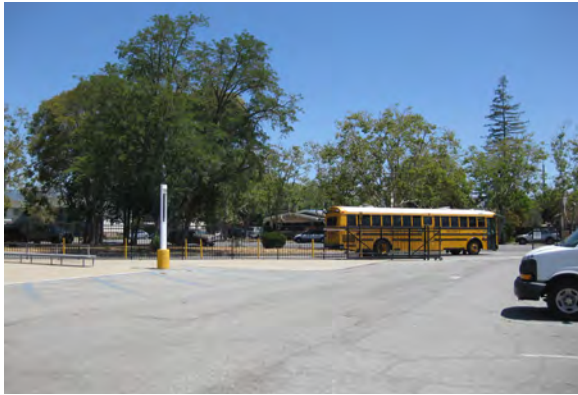
- Concrete paving in general is in poor condition with cracks, cuts and patched areas, and holes. Needs to be re-done.
- Paving and hardscape at quad needs to be re-done.
- Cross slope issues (>2%).
- Pool may not have been filled properly.

Typical concrete paving

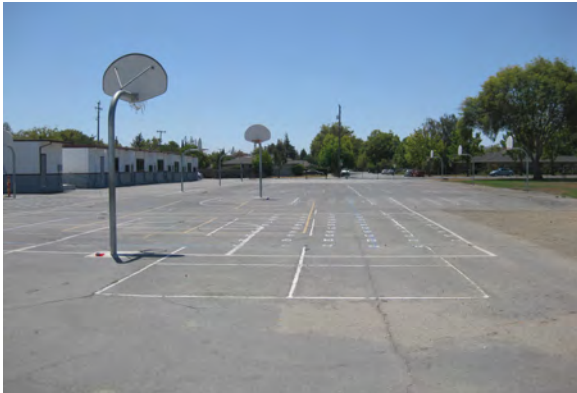
- Hardcourts are in poor shape with cracking and allowing water intrusion/ weed growth. Uneven surface. Needs to be re-done.
- Cross slope issues (>2%).
- Several areas where paving has degraded and are now just patches of dirt and areas where Portables were removed that were never re-paved.
- Electrical vault covers are uneven, creating trip hazards.

Typical AC paving at hardcourts

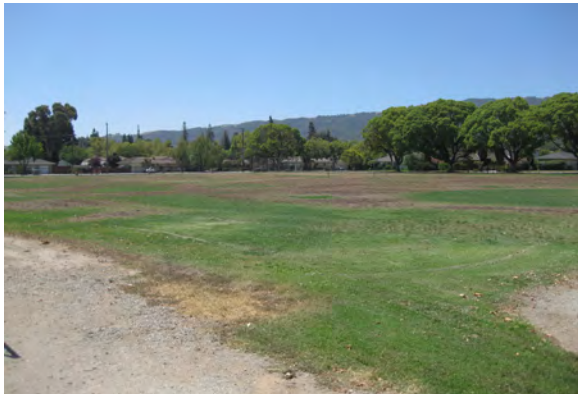
- Category [1]
- Fencing and gates are in good condition. Fencing along the front of the campus is steel ornamental fencing.
- Fencing along the fields are chainlink.
- Some gates appear to be missing panic hardware.

Perimeter fencing

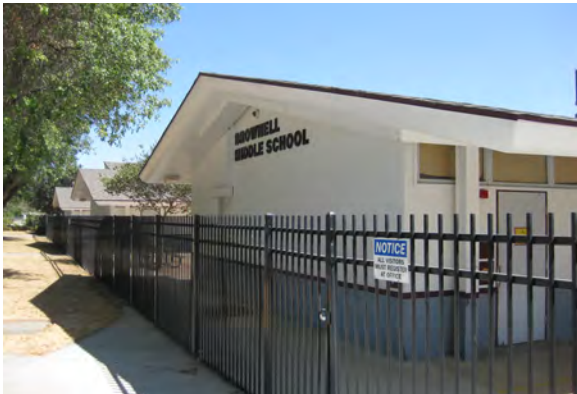
- Category [5]
- The site has accessibility issues throughout with uneven pavement, cross slope (>2%) issues, pavement cracks that are tripping hazards, grade changes, and steps with no ramps or guardrail.

General ADA conditions
