GILROY UNIFIED SCHOOL DISTRICT

FACILITIES MASTER PLAN

MARCH 2016

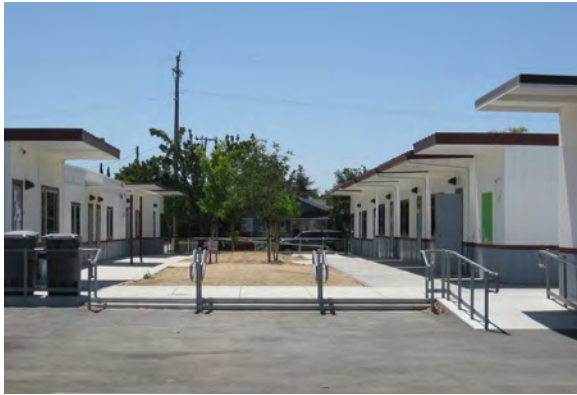
- Category [4]
- Exterior doors are in fair condition; all require new paint.
- Second door at Classrooms is original to the buildings and is in poor condition. The width and hardware do not comply with accessibility requirements. Some hardware is not functioning properly. Thresholds are non-compliant.
- New door safety locks were installed this Summer 2015.
- Door thresholds do not meet today's accessibility requirements.

Typical threshold

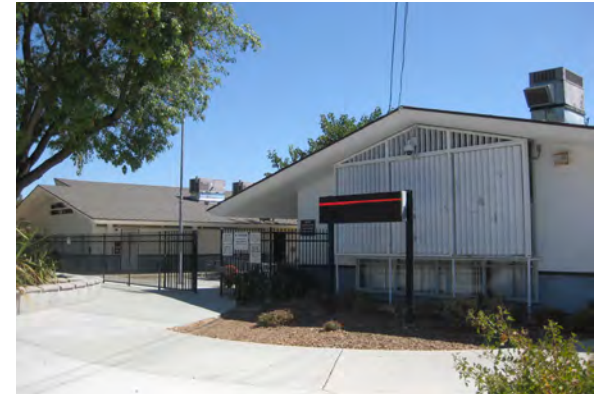
- Category [4]
- Exterior plaster is cracking and has holes in areas of the soffit; needs to be patched, repaired and painted.

Exterior paint conditions

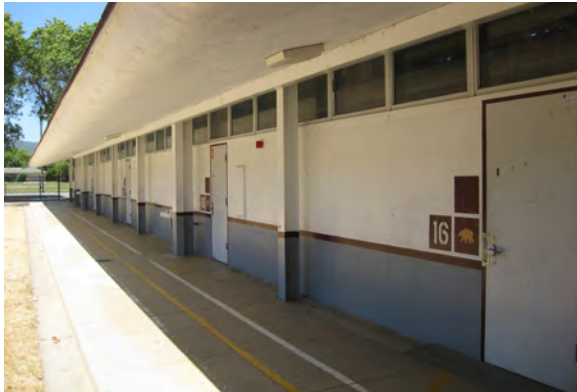
Exterior doors

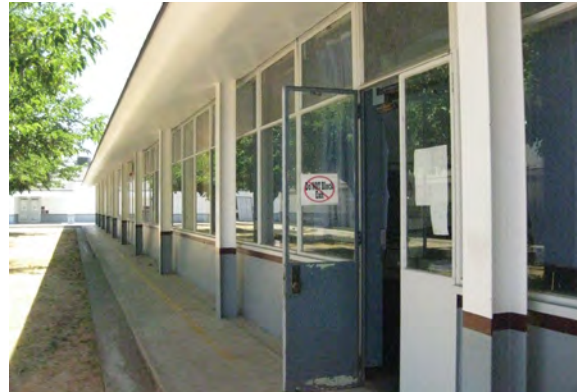
- Category [4]
- Windows are original, single pane. They need to be replaced. Most operable windows are not operational.

Exterior windows

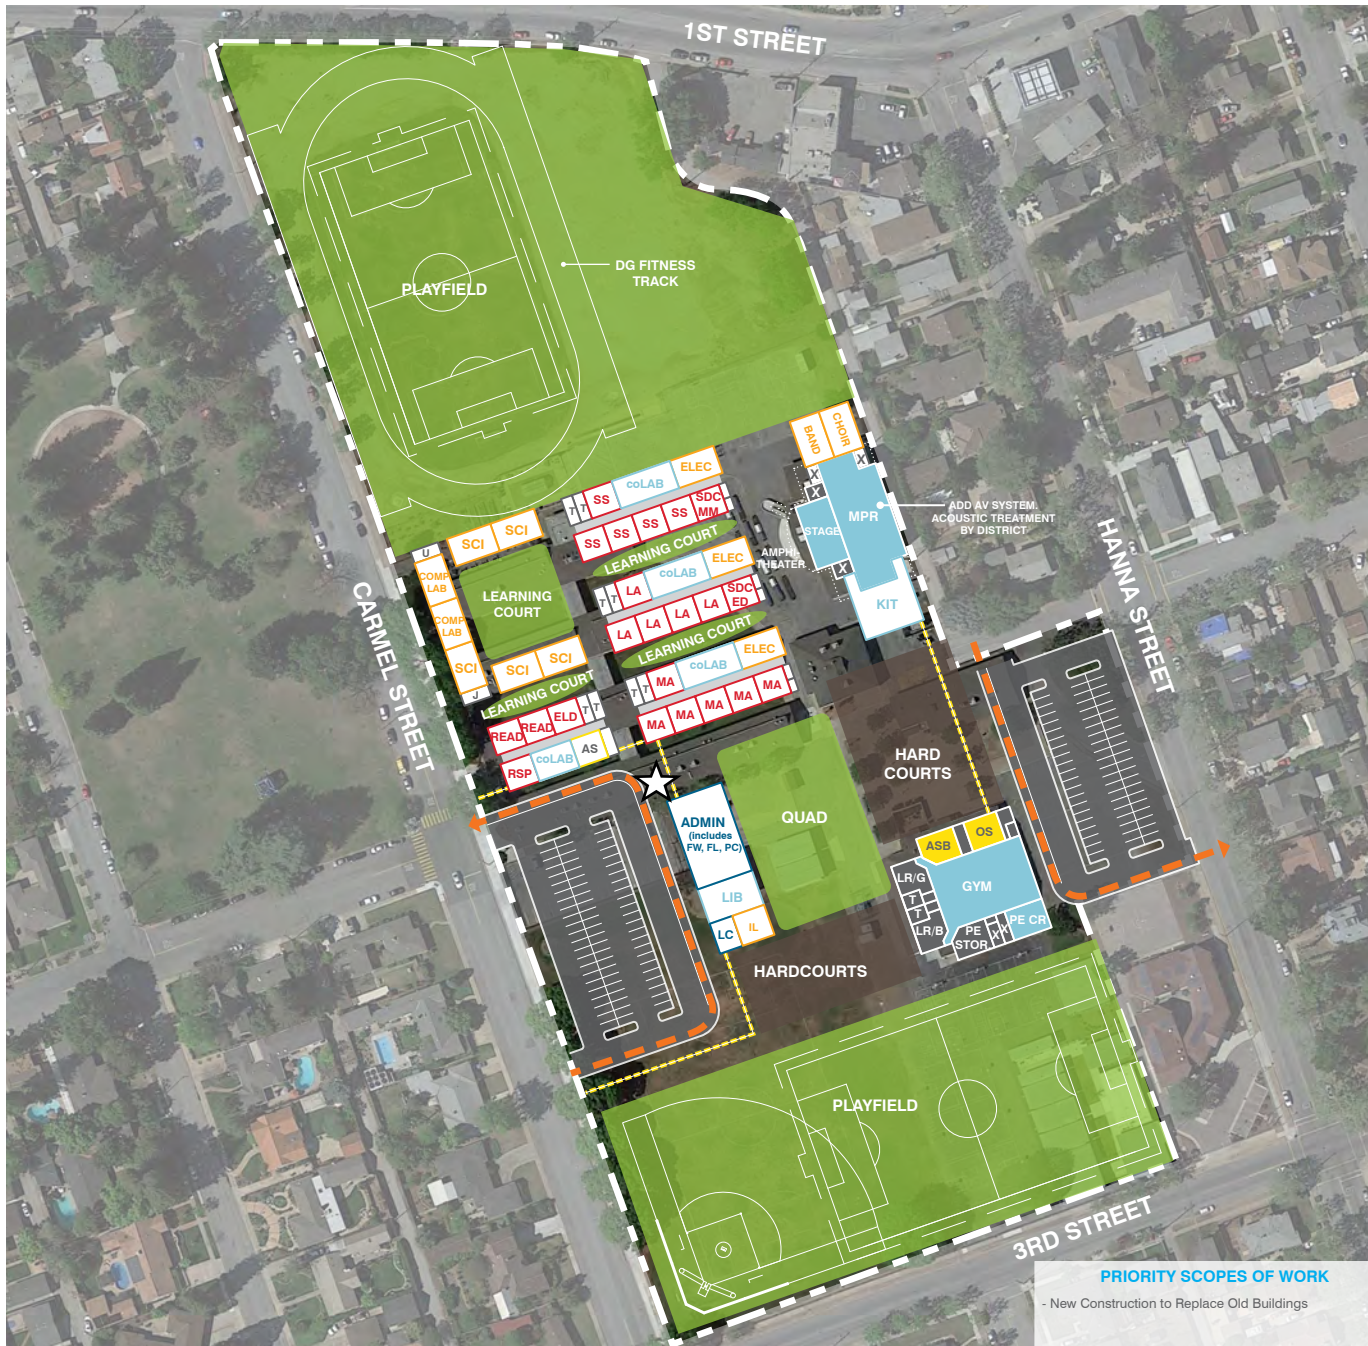
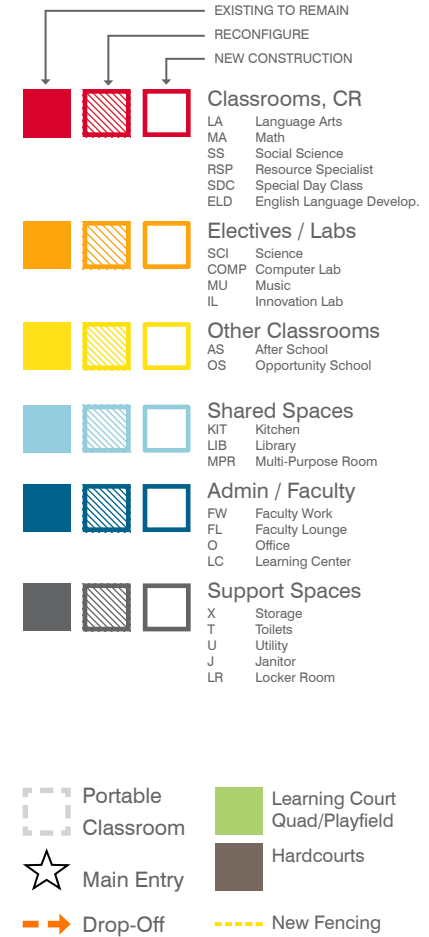
PRIORITY SCOPES OF WORK

- New Construction to Replace Old Buildings

Planning Capacity:	841
Teaching Stations:	
Language Arts, LA	5
Social Studies, SS	5
Math, MA	6
Science, SCI	5
Elective (2 - Performing Arts, 3 - Open)	5
Computer Lab (1 - Innov, 2 - Regular)	3
Special Day Class, SDC (1 - MM, 1 - SH)	2
Resource Specialist, RSP	1
After School, AS (Power School)	1
Other (2 - Read 180, 1 - ELD, 1 - ASB, 1 - PE Stor., 1 - Opportunity School)	6
Grand Total:	38

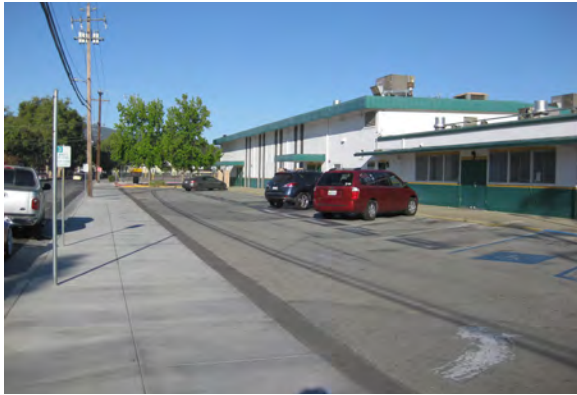
AC paving at parking area

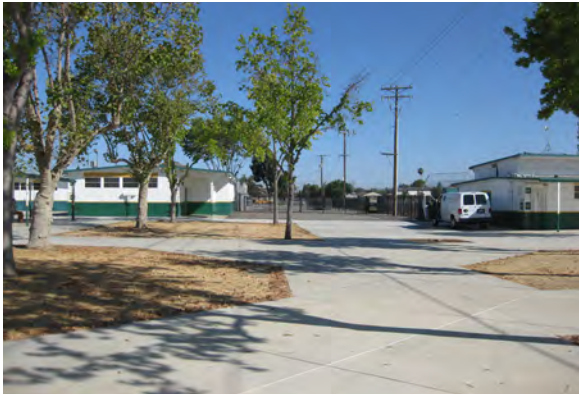
Typical concrete paving

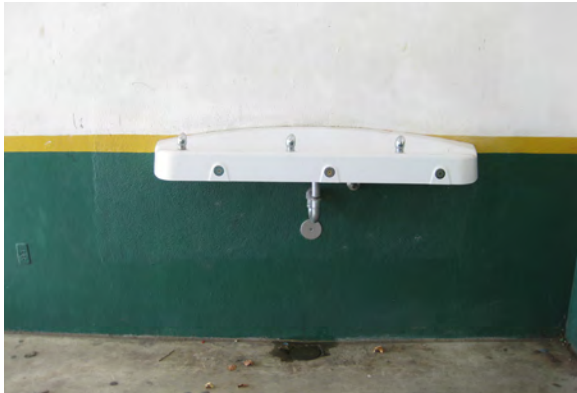
Typical drinking fountain

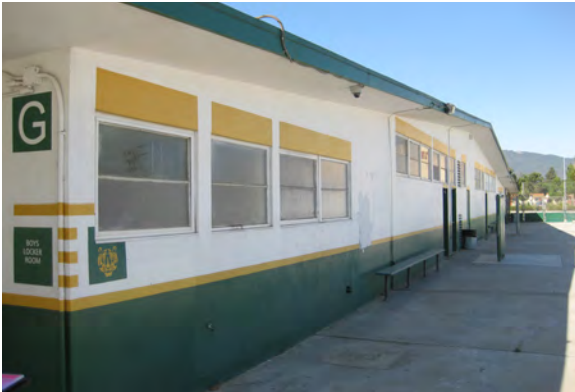
Exterior paint conditions

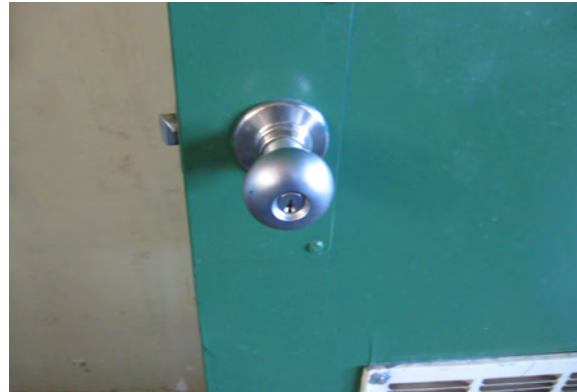
Exterior doors

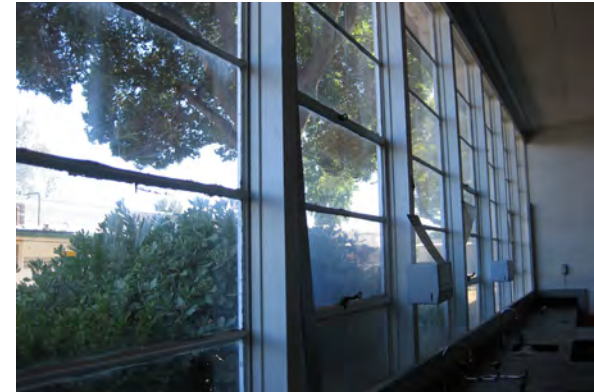
Exterior windows

- Category [5]
- Windows are original and single pane and need to be replaced. Most operable windows are non-operational.
- Sealant has degraded.

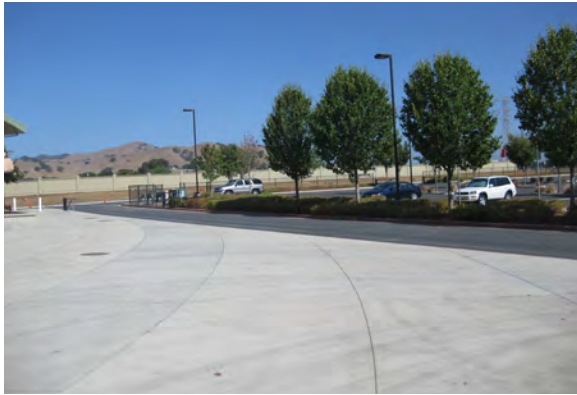
Bus lane

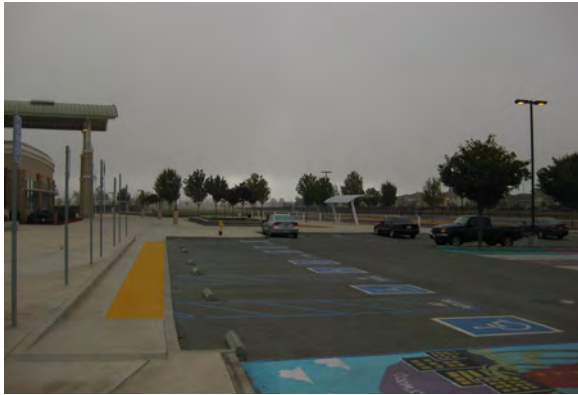
AC paving and ADA parking

- Parking lot AC paving is in good condition and just needs to be re-sealed and re-striped.
- The drop-off does not function well. There are many traffic issues during drop-off and pick-up times.

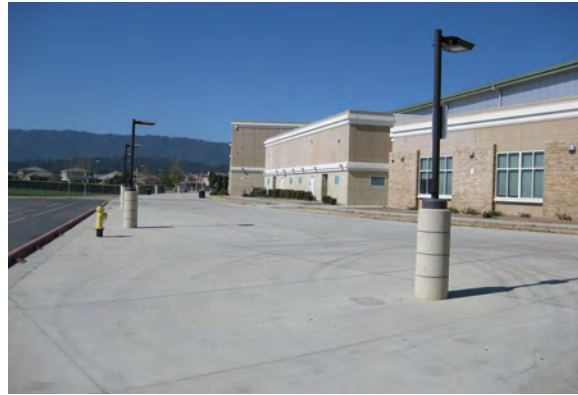
- Concrete paving in general is in good condition.

Concrete paving

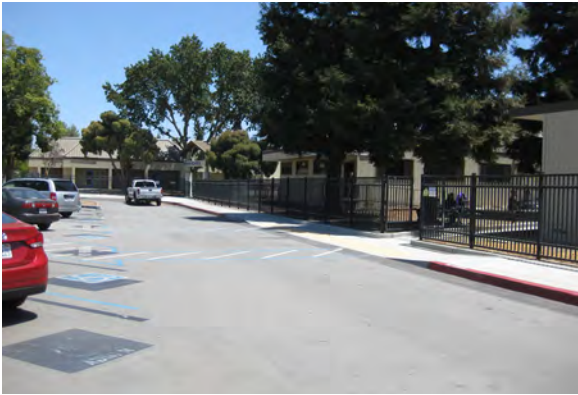
- The parking lot AC paving is in poor condition and needs to be re-done. Various areas are cracking.
- There is an ADA drop-off zone with truncated domes at the front parking lot.

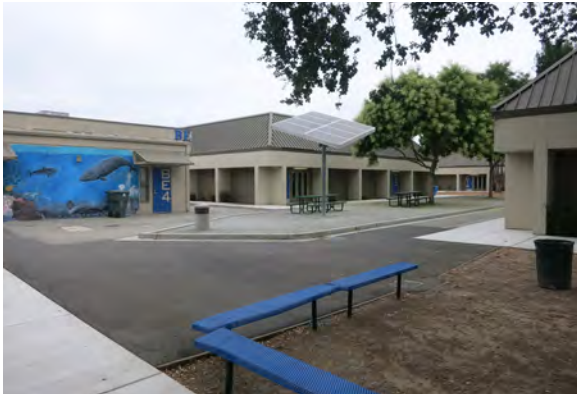
Campus paving

- Concrete paving in general is in good condition.
- The main quad was re-done in 2012.

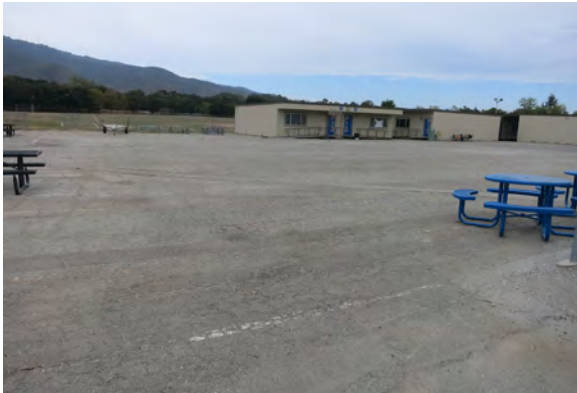
AC paving at hardcourts

- AC paving throughout the site and at the hardcourts is in poor condition and needs to be re-done; cracking allowing water intrusion/ weed growth.
- Some areas beyond the main quad may have cross slope (>2%) issues that will need to be evaluated for ADA compliance.

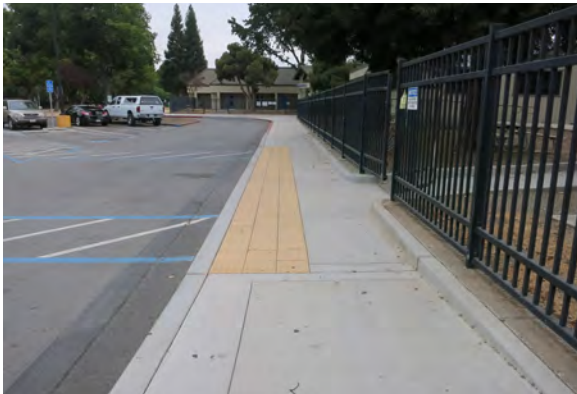
Perimeter fencing

- Category [2]
- Fencing is in good condition.
- Fencing along the front of the campus is steel ornamental fencing.
- Fencing along the fields is chainlink.

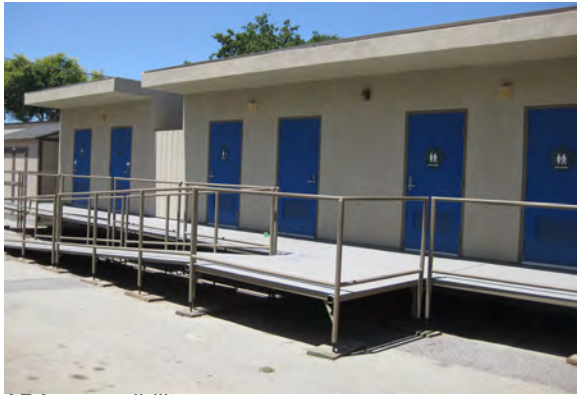
ADA accessibility

- Concrete ramps appear to be in good condition and are ADA compliant.
- Portable ramps appear to be in fair condition.

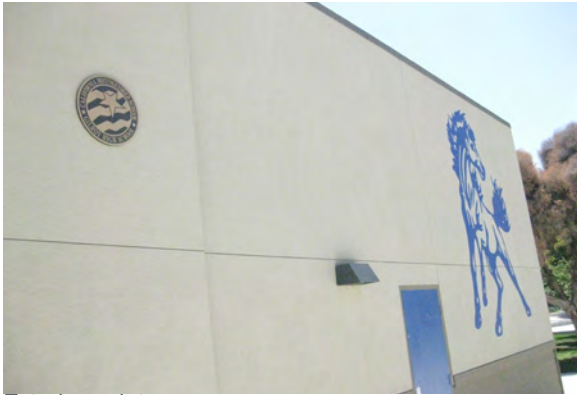
Exterior paint

- Category [1]
- Building paint is in good condition.

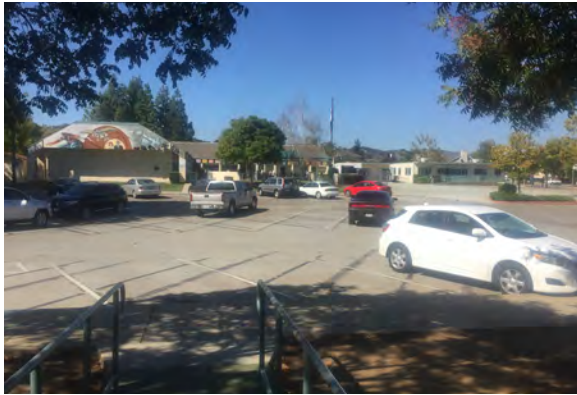
Parking

- Parking lot AC paving needs to be re-surfaced and re-stripped.
- Truncated domes missing from ADA drop-off zone.
- Signage missing at parking lot entrance.(tow-away)

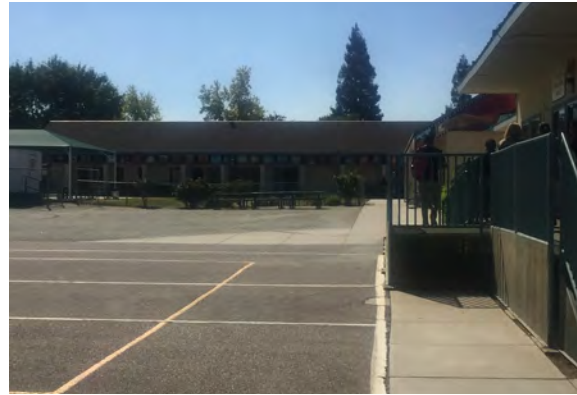
Paving at Quad

- Concrete paving in general is in good condition. Some areas of cracking may need to be replaced.

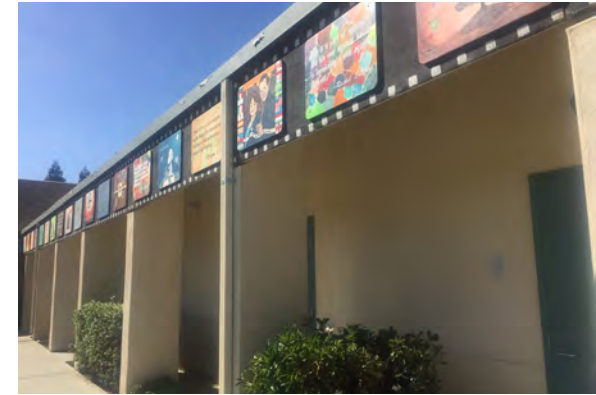
Exterior of buildings

- Category [3]
- Building paint is in good condition. In general, the site could use a fresh coat of paint.

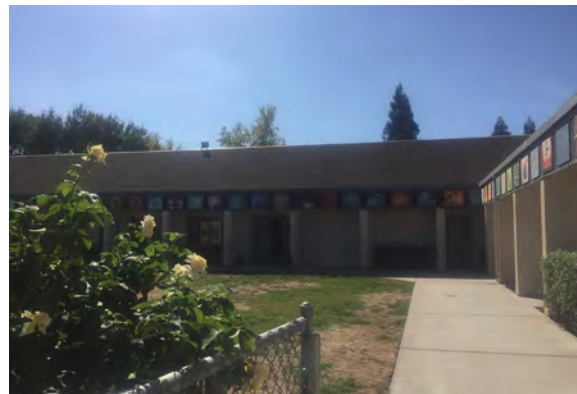
Landscaping

- There are minimal areas of landscaping, mainly grass areas that are currently in poor condition with many eroded areas.

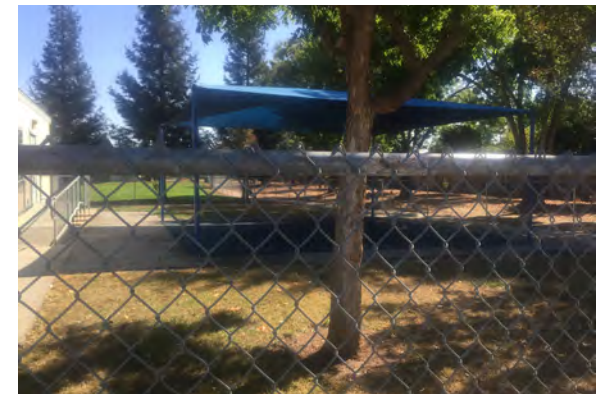
Perimeter fencing

- Category [5]
- There is no fence at this site. Maintenance noted that there is a need to have a fence for this site for security reasons. Fence will be installed in upcoming project.

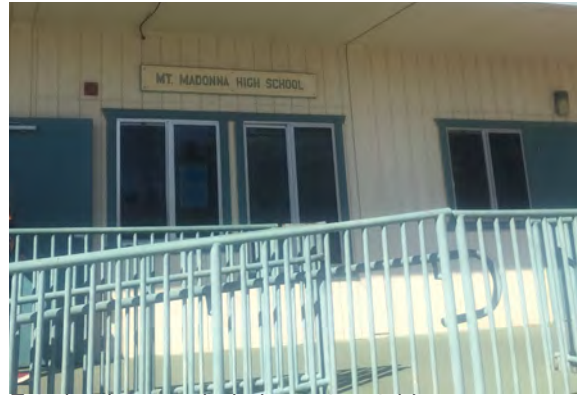
Exterior doors and windows at portables

- Category [1]
- Exterior doors are in good condition. They need a new coat of paint.
- Magnetic lock hardware have recently been installed (Summer 2015).

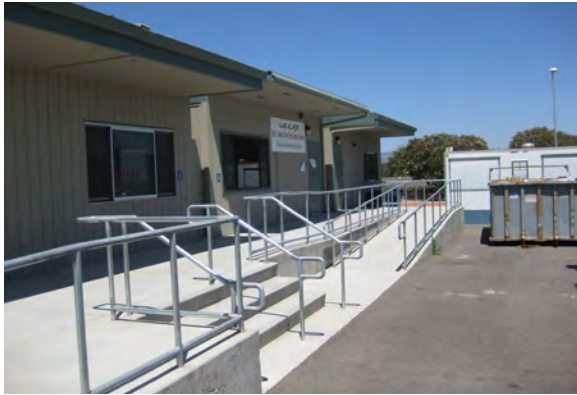
Main Administration and Classrooms

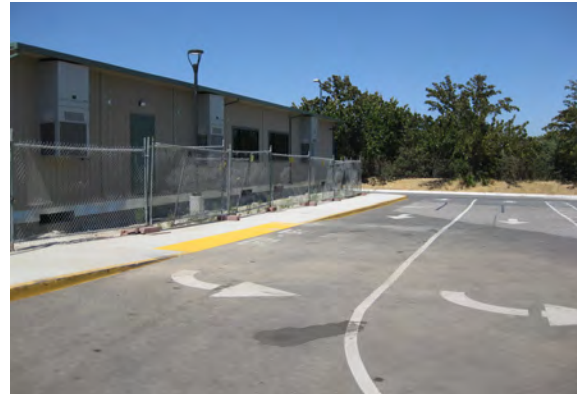
Drop-off area

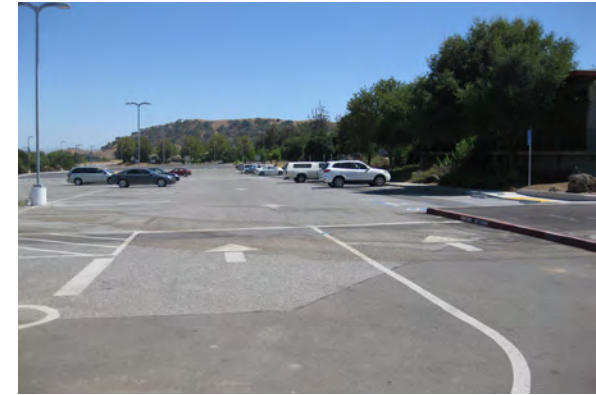
Parking - shared with the college

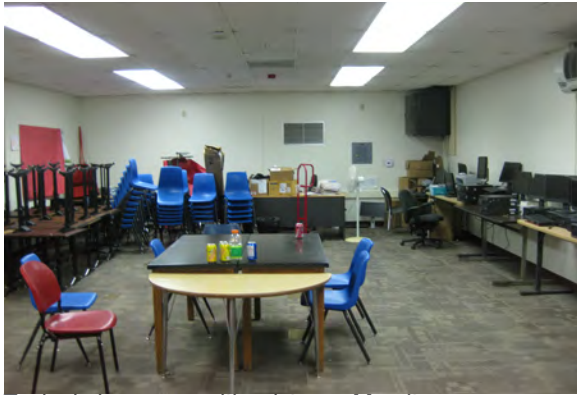
Typical classroom with mixture of furniture

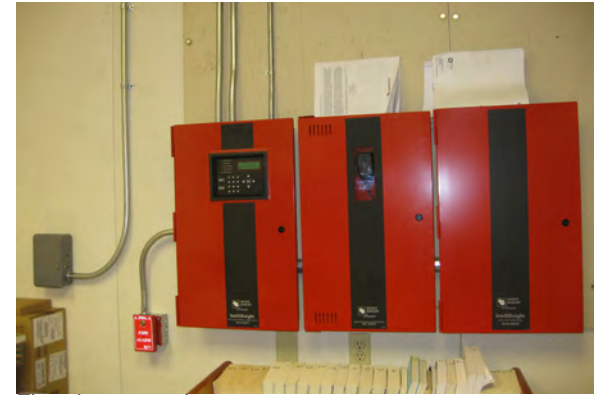
Fire alarm panels

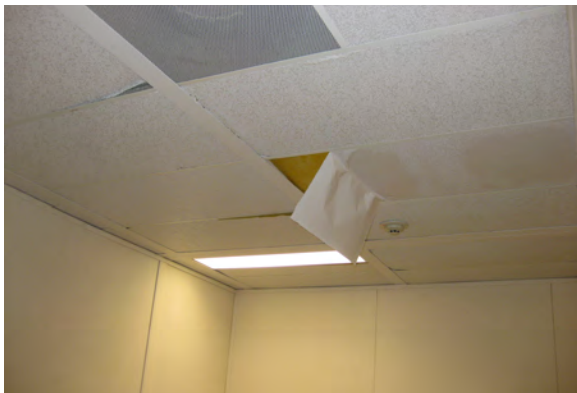
Ceiling in Biology storage room

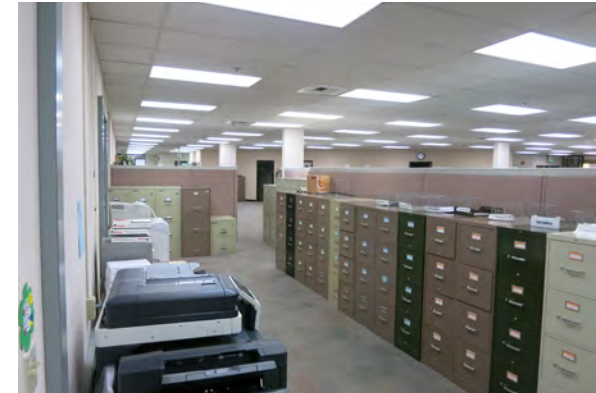
Typical open office area with file cabinets

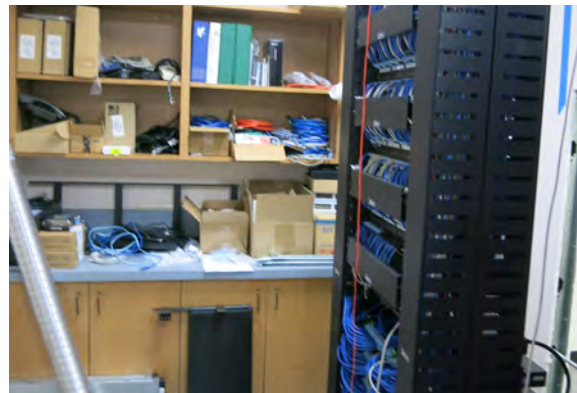
District data center

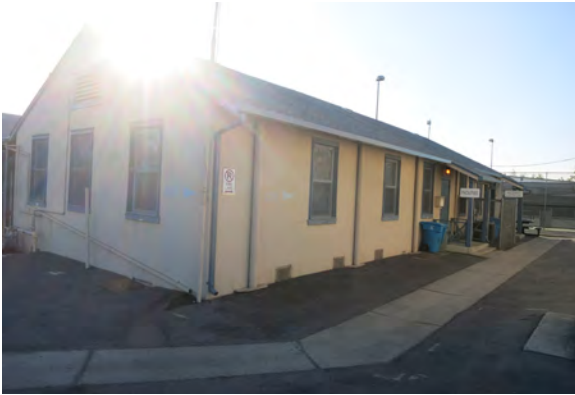
Facilities / Maintenance & Operations Offices

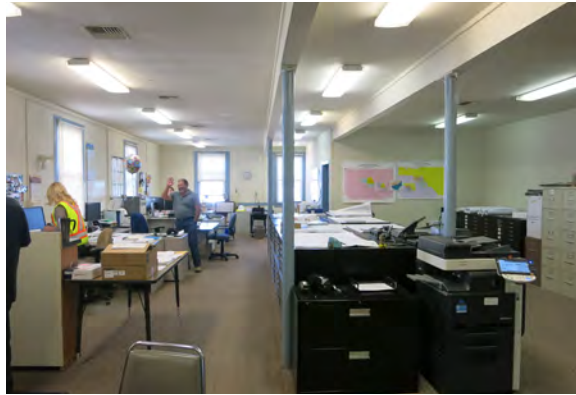
Facilities / M&O open office and plan room

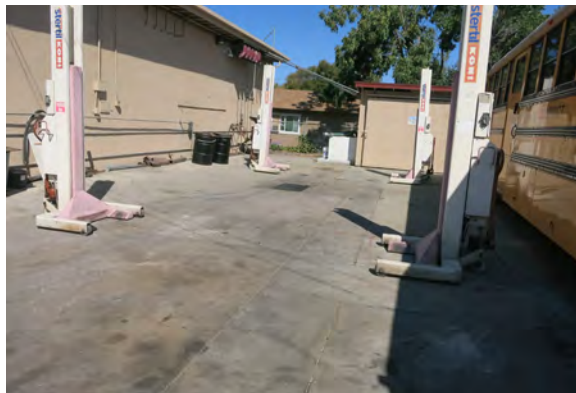
Bus service lift area with no shade

4. Shade at bus parking to decrease wear.

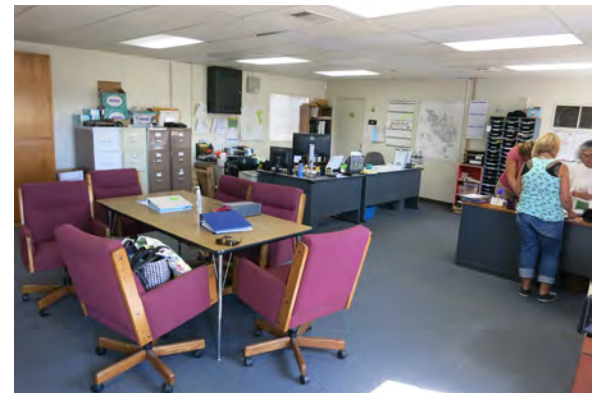
Transportation offices and meeting area

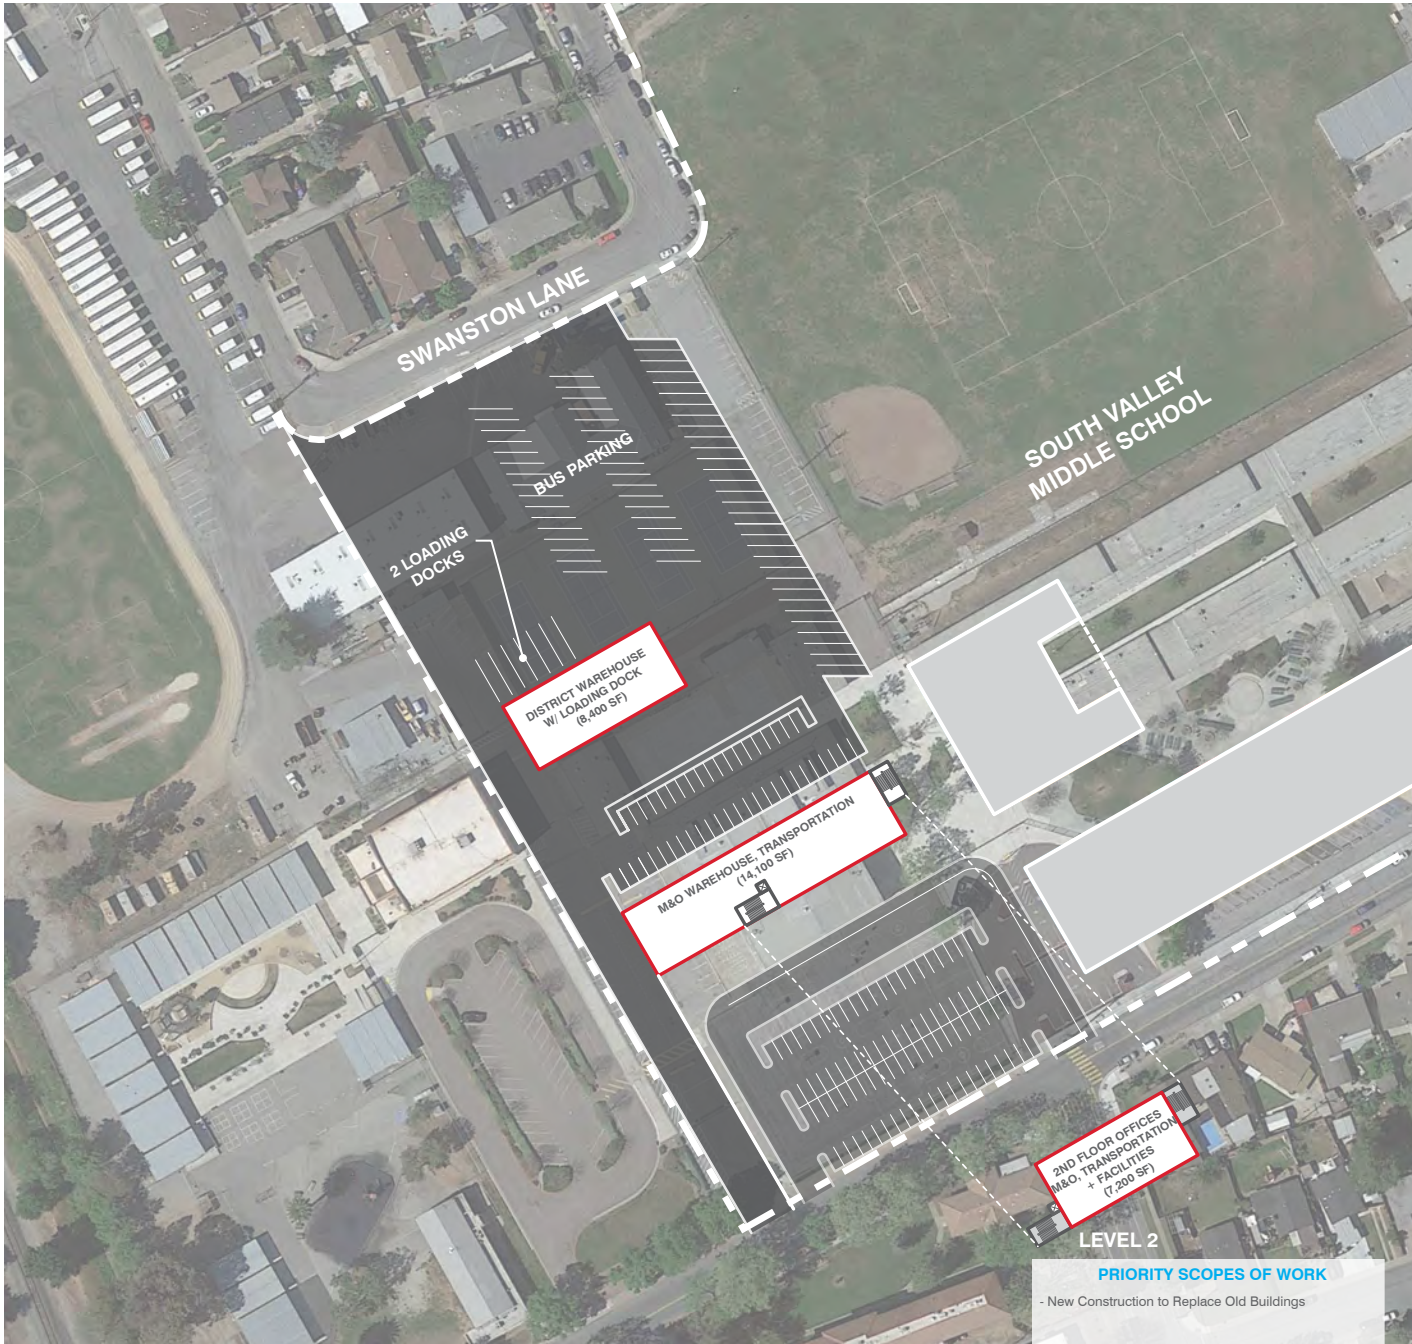
NEW CONSTRUCTION
 Butler / Pre-engineered Building

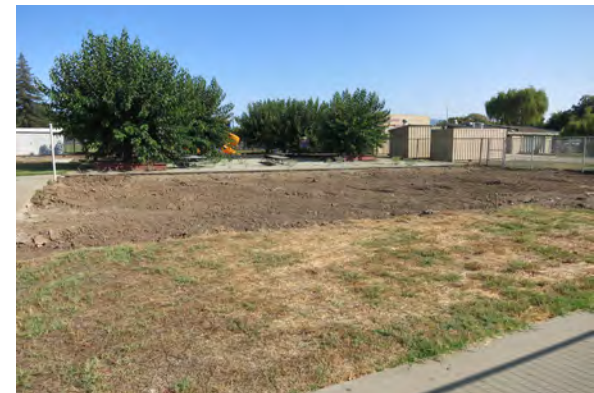
9th Street lot, adjacent to Glen View. Potential site to relocate displaced preschool at Antonio del Buono

- The two pre-school portables at Antonio del Buono will need to be returned to Head Start this year. Therefore, there is an immediate need for two new pre school classrooms. A potential site for this is on the 9th Street site adjacent to Glen View Elementary School. The site is empty and the play yard will need to be re-done to meet pre school licensing requirements.

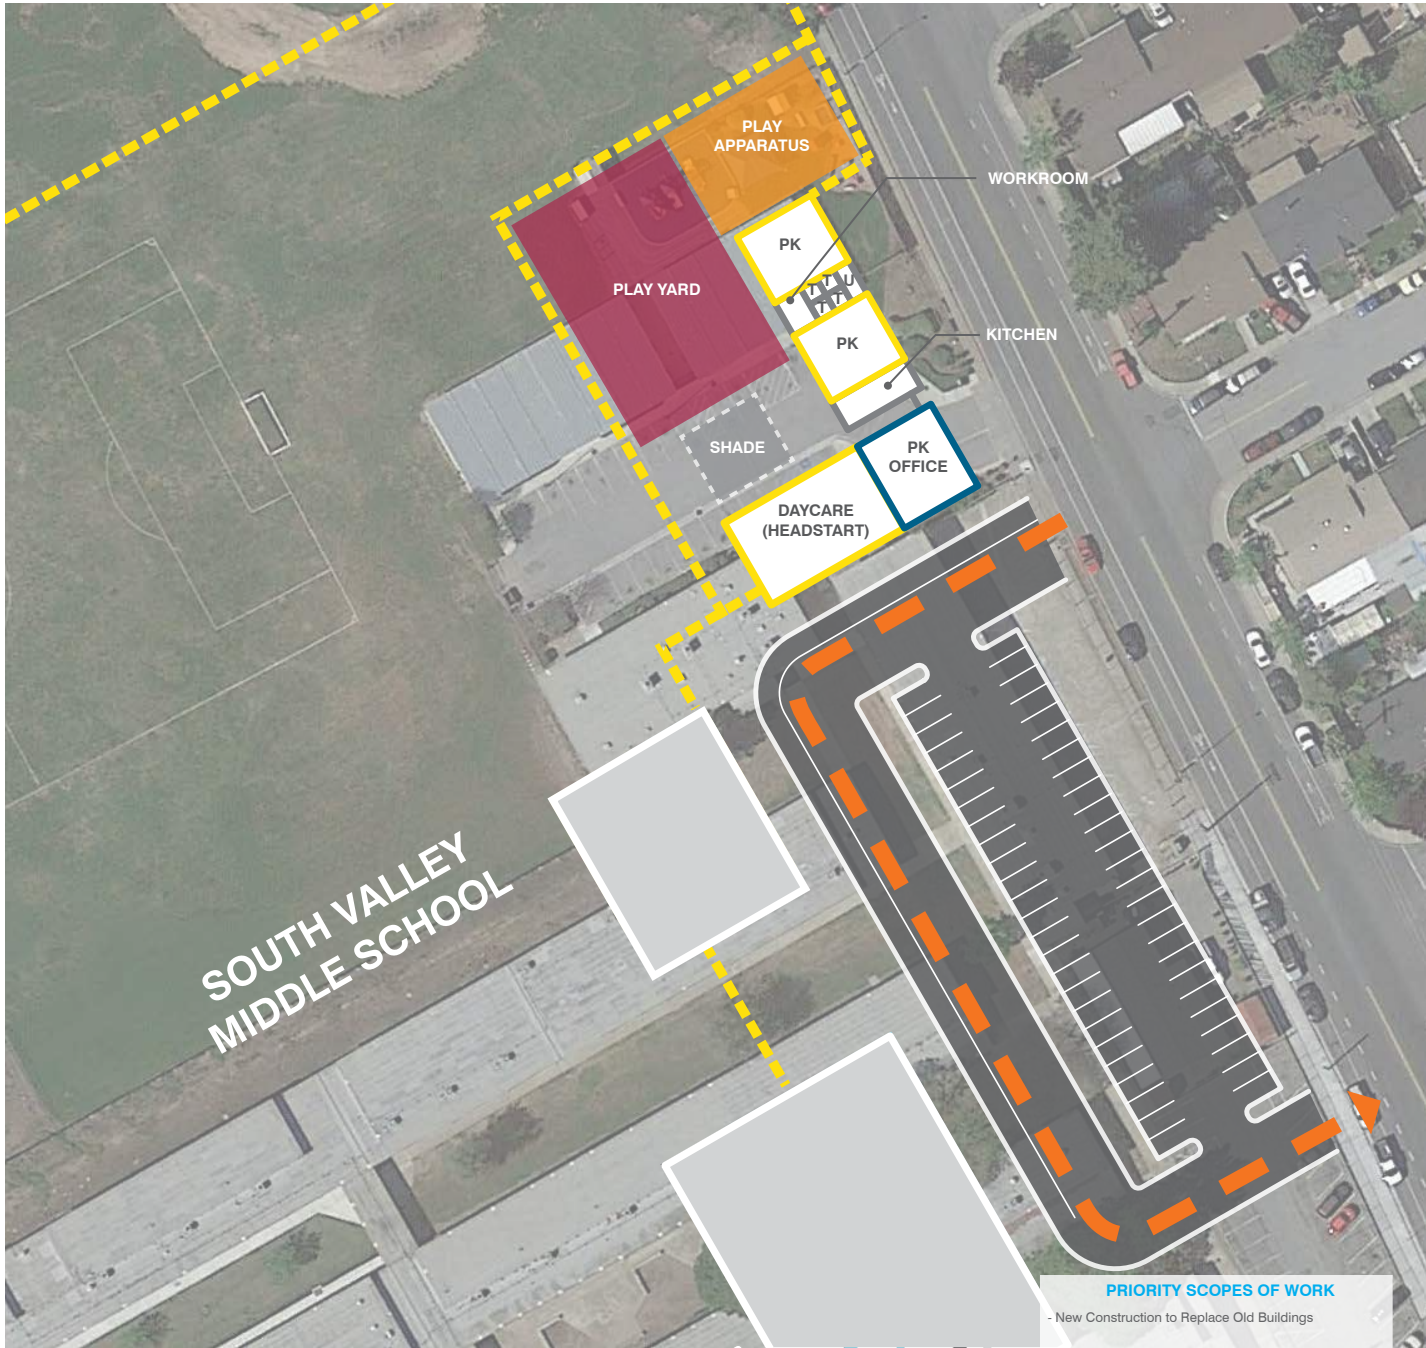
- NEW CONSTRUCTION
- Administration/ Office
 - Classrooms
PK Pre-School
 - Support Spaces
T Toilets
U Utility
 - Drop-Off
 - New Fencing
